# Poor House Run Hydrologic Assessment and Watershed Action Plan

April 1, 2022

## Appendix A: Project Sites and Estimated Nutrient and Sediment Reductions

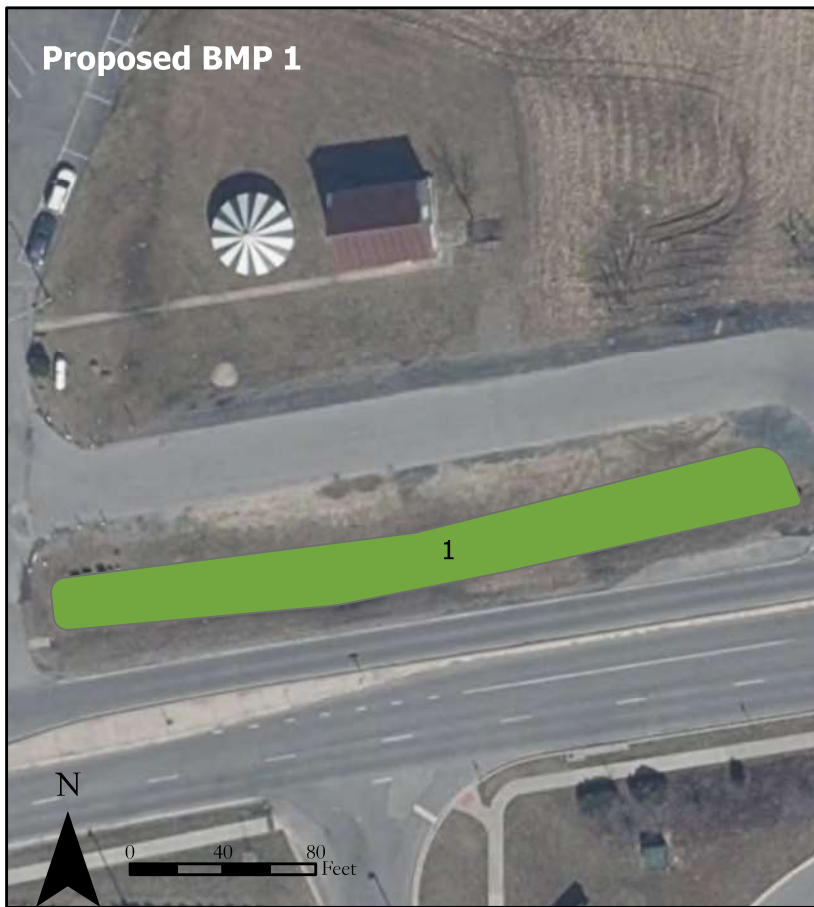
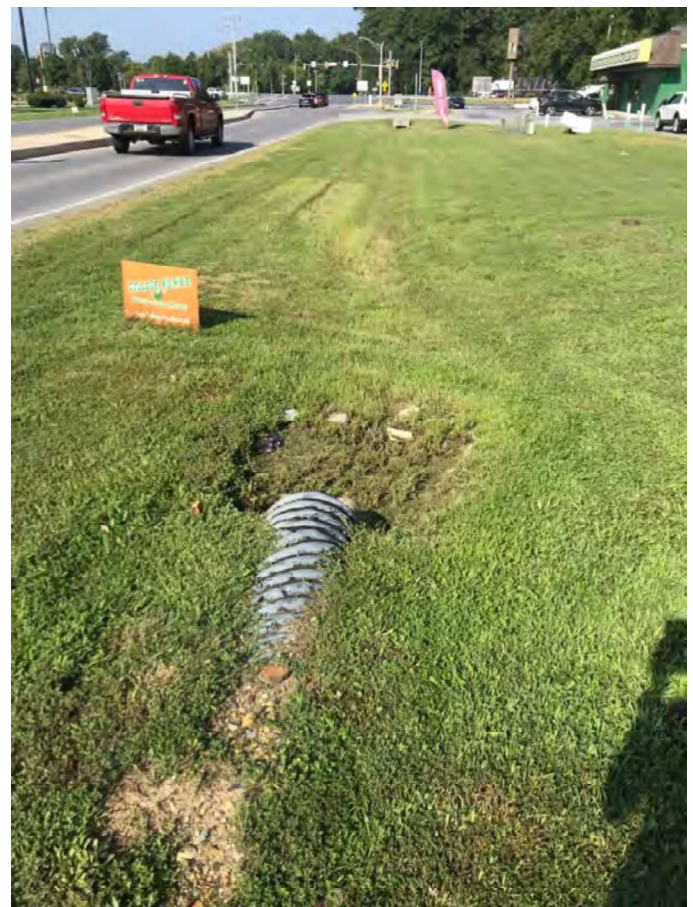
This site has potential to be retrofitted to a vegetated open channel (or bioswale). It is located near the intersection of Legion Rd. and 404 (Shore Hwy). At present, the swale is mowed and has no stormwater practices to reduce stormwater volume or treat nutrients. The swale eventually outlets to a pipe that goes under 404 and discharges into a forested corridor adjacent to Poor House Run. A vegetated open channel could be installed that has small pooling areas with soil amendments added to help infiltrate water. Another option is to maintain a similar swale configuration but be planted with native species to provide some habitat and storm flow velocity reduction value.

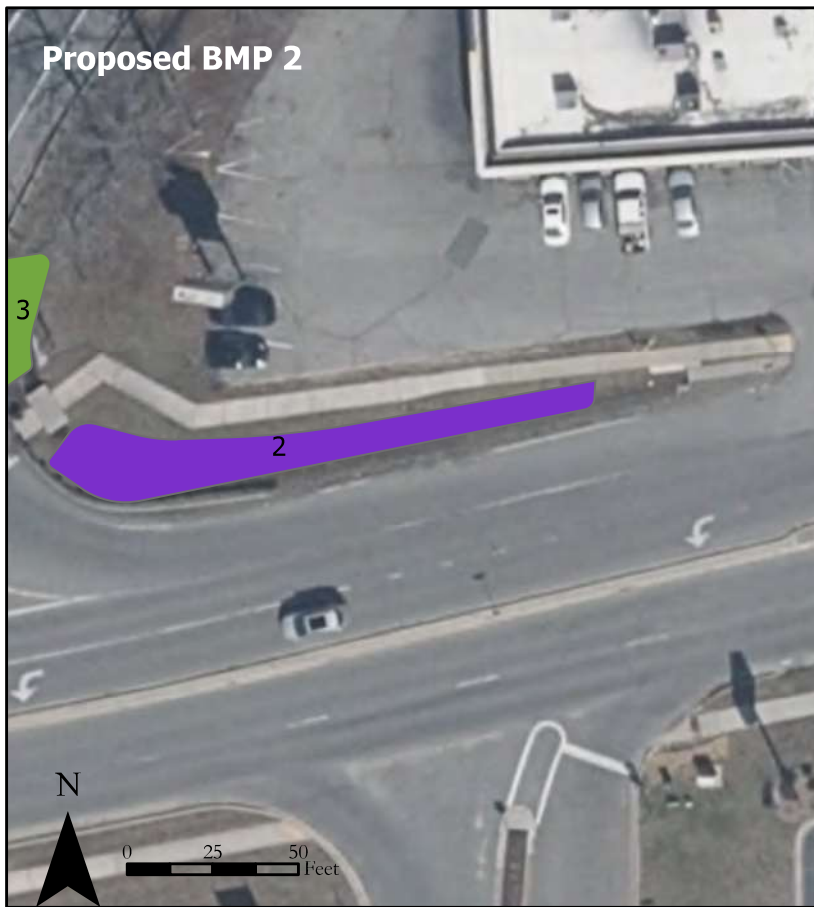
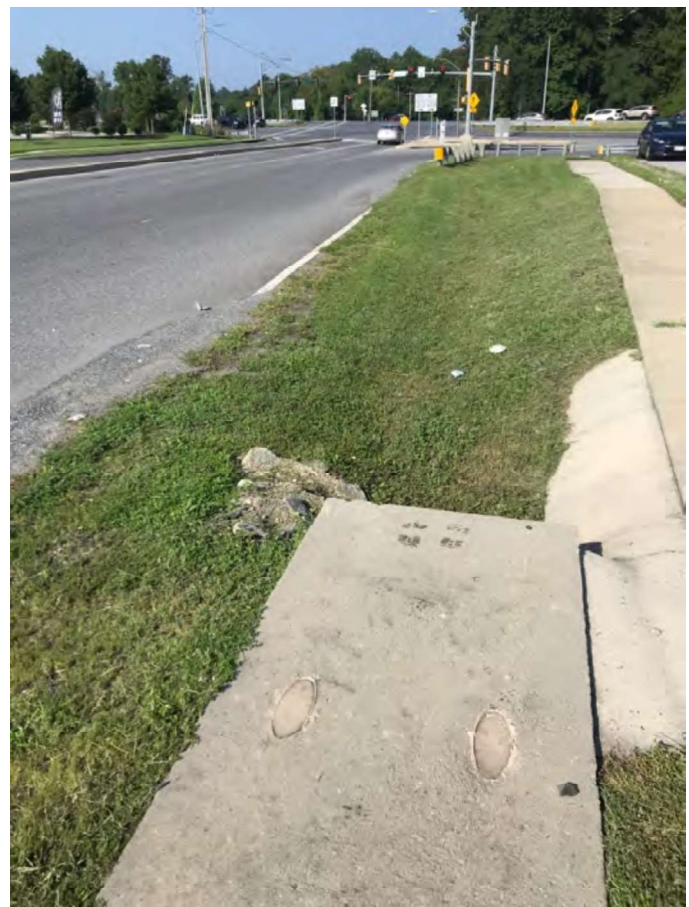
This site has potential to be retrofitted to a bioswale. It is located near the intersection of Legion Rd. and 404 (Shore Hwy) and receives water from BMP 1. At present, the swale is mowed and has no stormwater practices to reduce stormwater volume or treat nutrients. The swale eventually outlets to a pipe that goes under 404 and discharges into a forested corridor adjacent to Poor House Run. A bioswale could be engineered for this location that would allow some water to infiltrate while maintaining the ability to convey stormwater and not flood the road. There are many constraints at this site with the road and sidewalk very close to the swale. There could also be utilities that are under the swale that could limit the project scope and size.

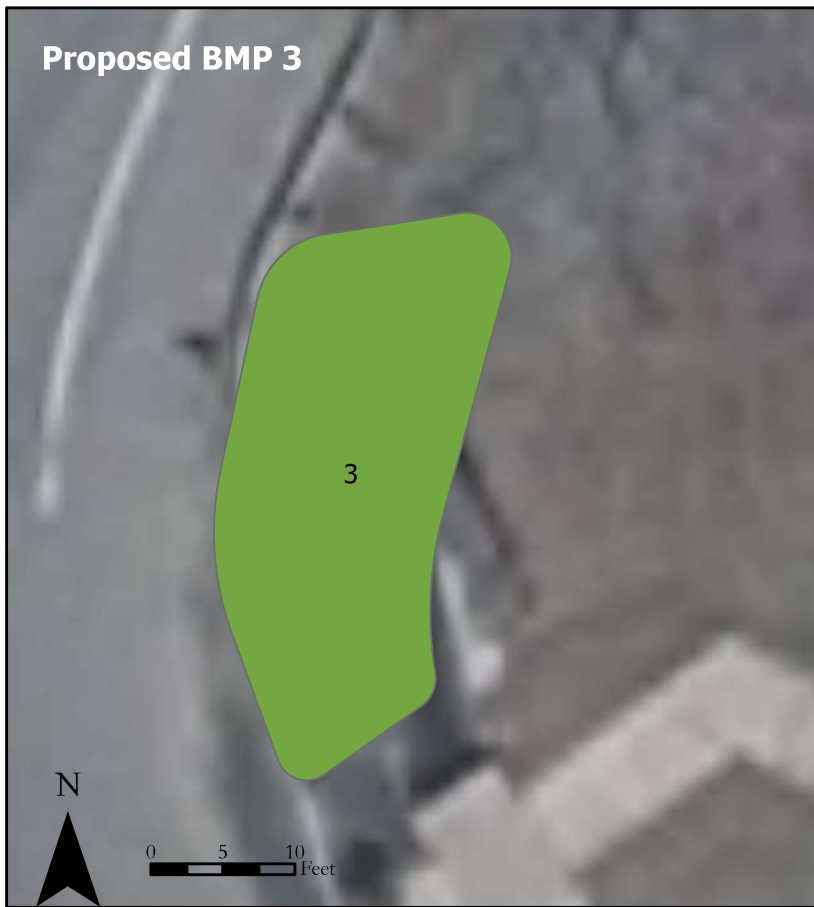
## Proposed BMP 3

This site has potential to be retrofitted to a vegetated open channel (or bioswale). It is located near the intersection of Legion Rd. and 404 (Shore Hwy) and receives stormwater from BMP 1 and BMP 2. At present, the swale is mowed and has no stormwater practices to reduce stormwater volume or treat nutrients. The swale eventually outlets to a pipe that goes under 404 and discharges into a forested corridor adjacent to Poor House Run. A vegetated open channel could be installed that has small pooling areas with soil amendments added to help infiltrate water. Another option is to maintain a similar swale configuration but be planted with native species to provide some habitat and storm flow velocity reduction value.

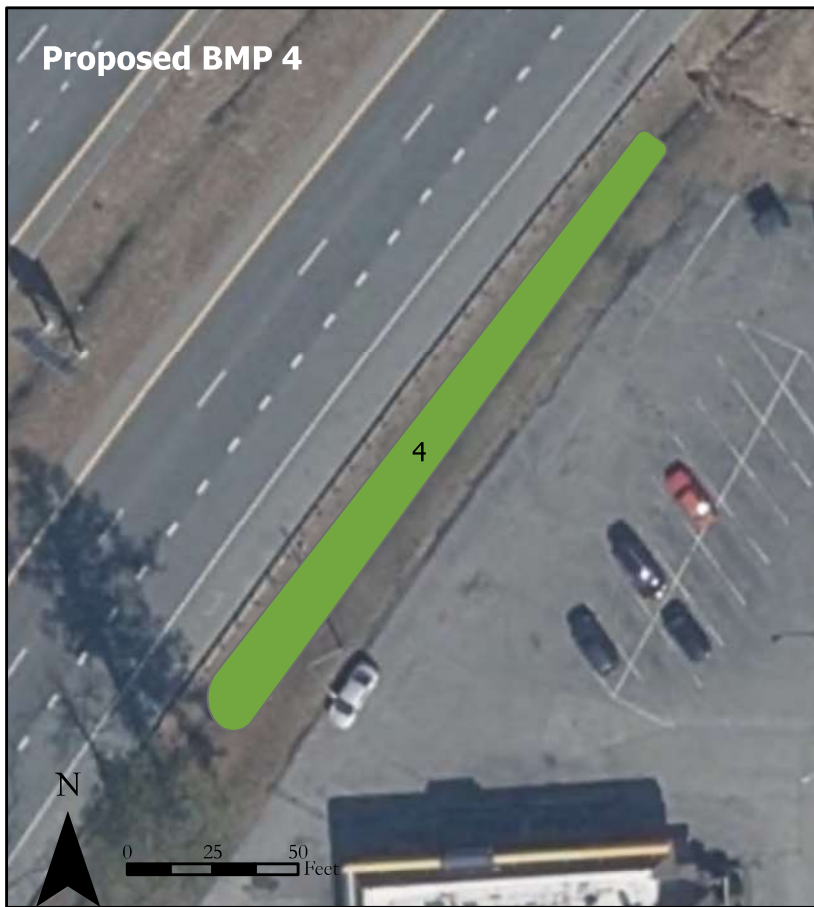
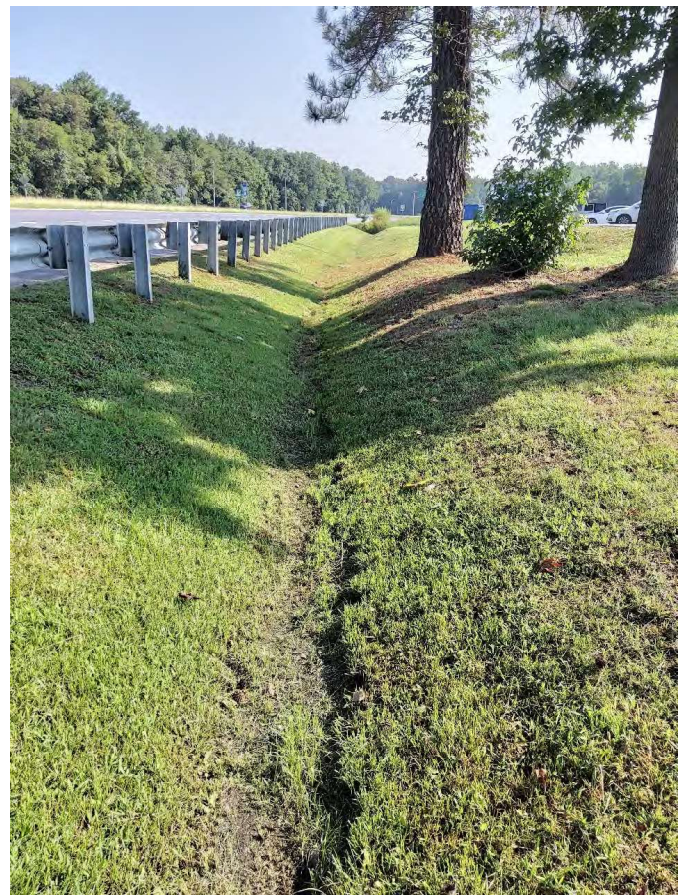
This site has potential to be retrofitted to a vegetated open channel (or bioswale). It is located near the intersection along 404 (Shore Hwy) and receives stormwater from BMP 1, BMP 2, and BMP 3. At present, the swale is mowed, is starting to erode, and has no stormwater practices to reduce stormwater volume or treat nutrients. The swale eventually outlets to a pipe that goes under 404 and discharges into a forested corridor adjacent to Poor House Run. A vegetated open channel could be installed that has small pooling areas with soil amendments added to help infiltrate water. Another option is to maintain a similar swale configuration but be planted with native species to provide some habitat and storm flow velocity reduction value.

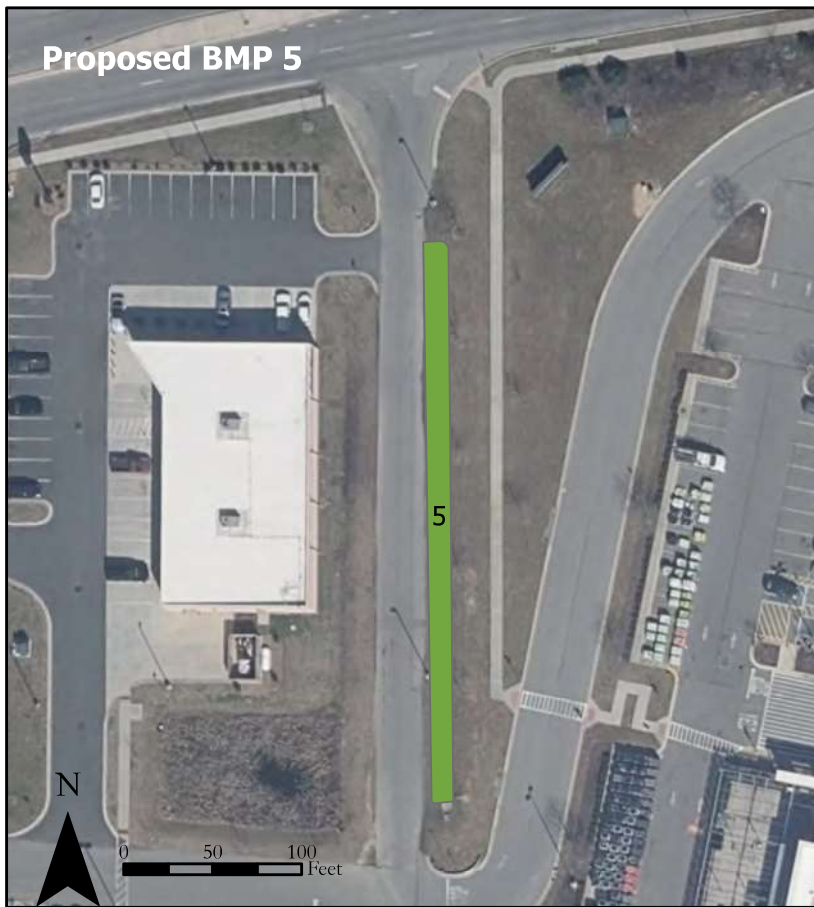
This site has potential to be retrofitted to a vegetated open channel (or bioswale). At present it is a concrete swale that is efficient and moving stormwater. It is located in the median between the access road that connects to AutoZone and the access road that leads to the Walmart parking lot. The concrete swale goes under the access road and daylights to another concrete swale that eventually connects into the underground stormwater system. The concrete could be removed and the swale regraded and planted out with suitable vegetation. The soil could also be amended to better infiltrate water. The swale could be enlarged slightly to handle and infiltrate larger storm flows but there are site restrictions that limit the ability to make this into a larger stormwater project.

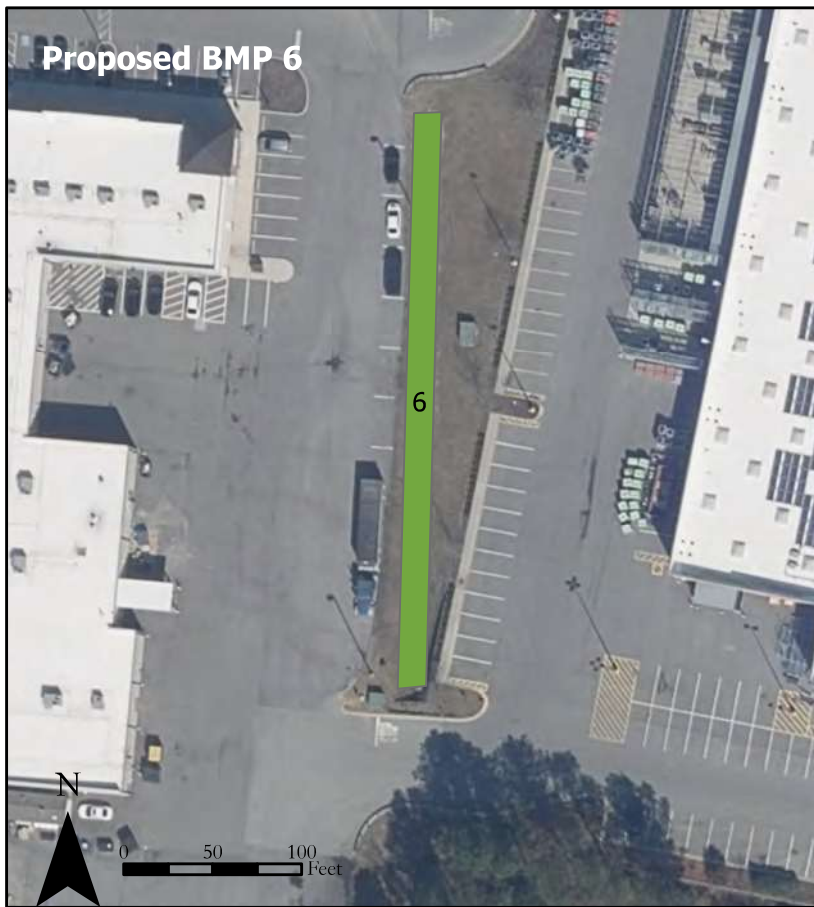
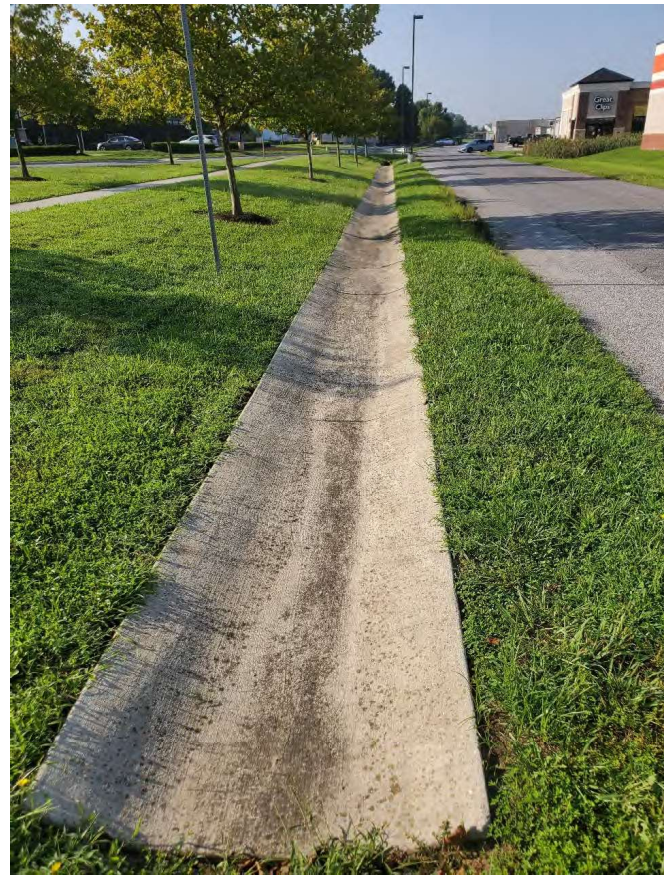
This site has potential to be retrofitted to a vegetated open channel (or bioswale). At present it is a concrete swale that is efficient and moving stormwater. It is located in the median between the access road for the Denton Plaza strip mall and the Walmart parking lot. There is not much space to work in so a vegetated open channel is the best option. Some small check dams could be added to the swale to temporarily pond water and there might be an opportunity to amend the soils to infiltrate some water but this site is constrained by the utilities and limited by the parking lot and access road.

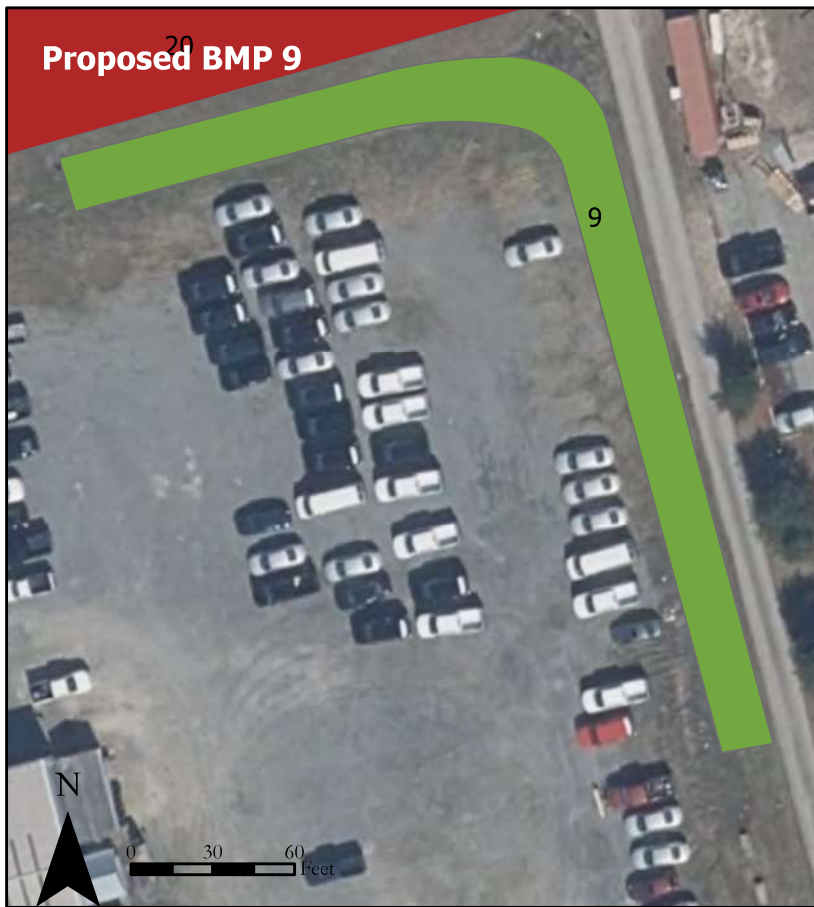
This site is located at the back of an auto dealership. The area highlighted is already wet ground with some drainage issues. A vegetated channel could be added to help convey water better but also provide stormwater attenuation from the impervious areas that are adjacent. A bioretention might also work but greater soils investigation needs to be completed to understand the infiltration capacity and whether an under drain could be added to help with drainage.

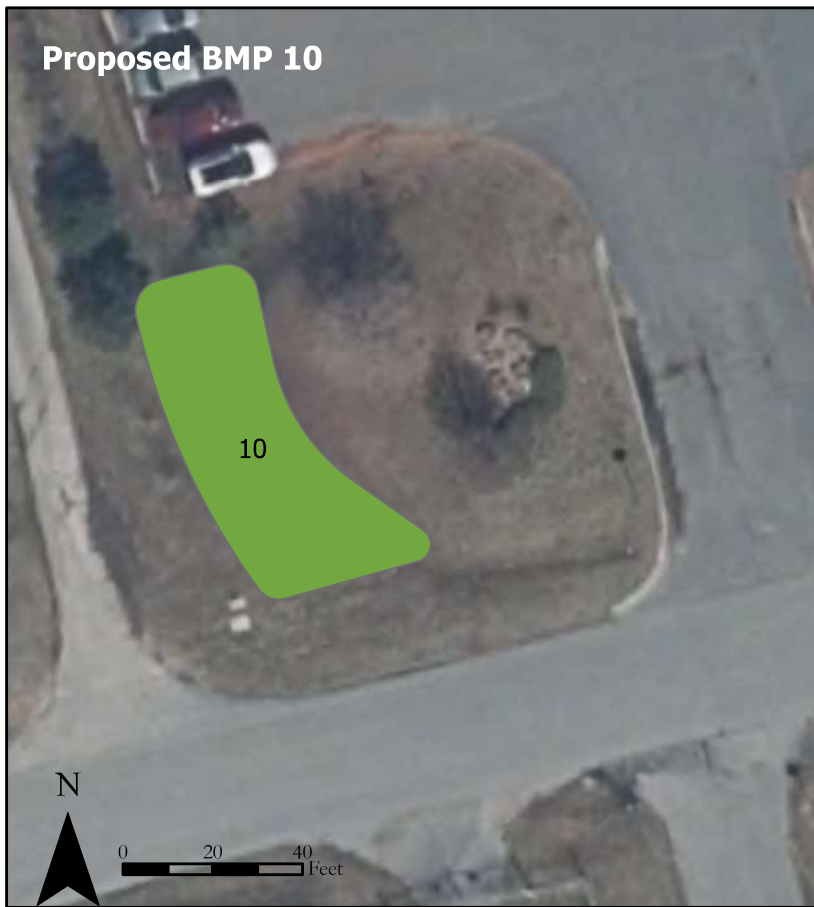
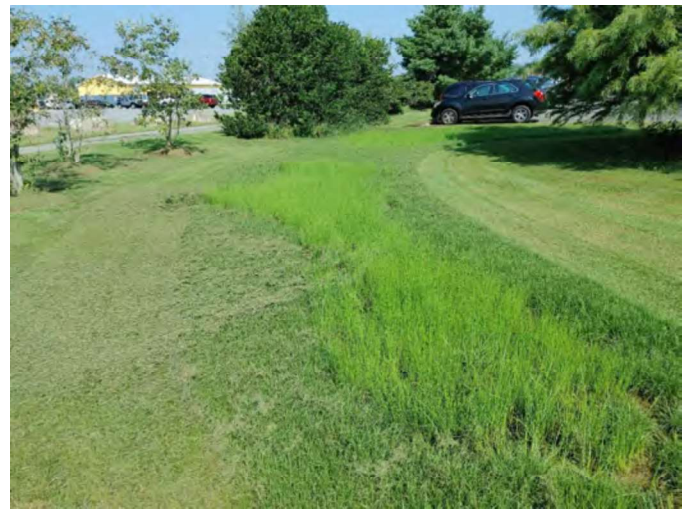
This site is located along Engerman Ave. at the entrance of Tanglewood Conservatories. The area is already wet and receives water from the roadside ditch and the parking lot. The site could be planted more extensively with native species or designed into a bioretention area. An underdrain or soil amendments might be necessary to ensure drainage of a bioretention.

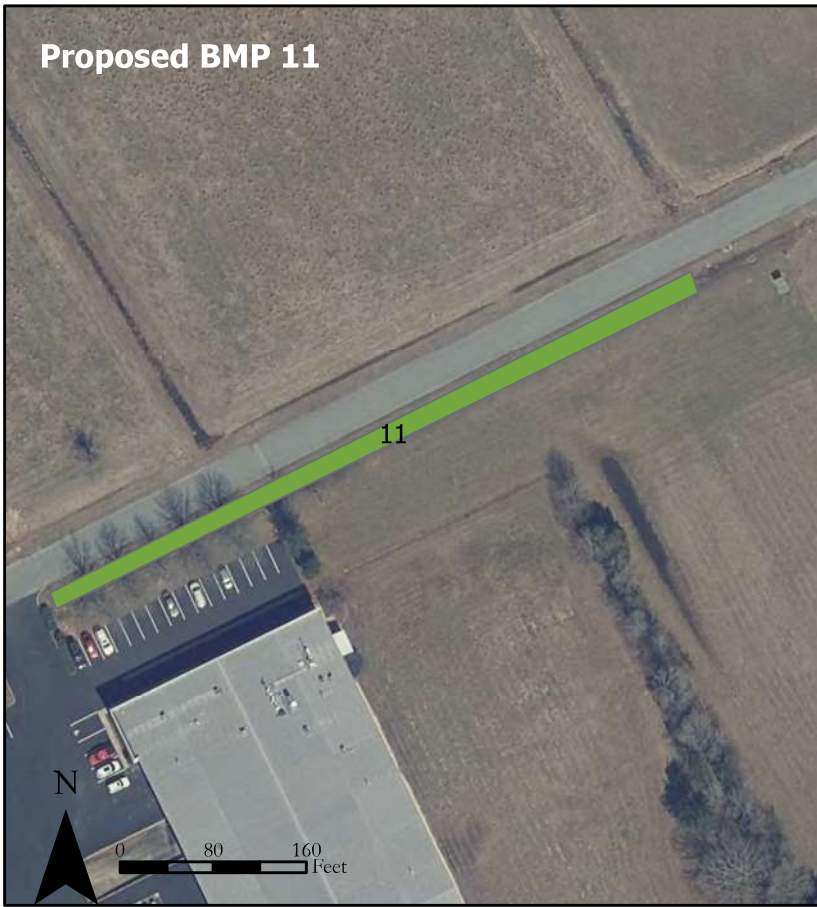
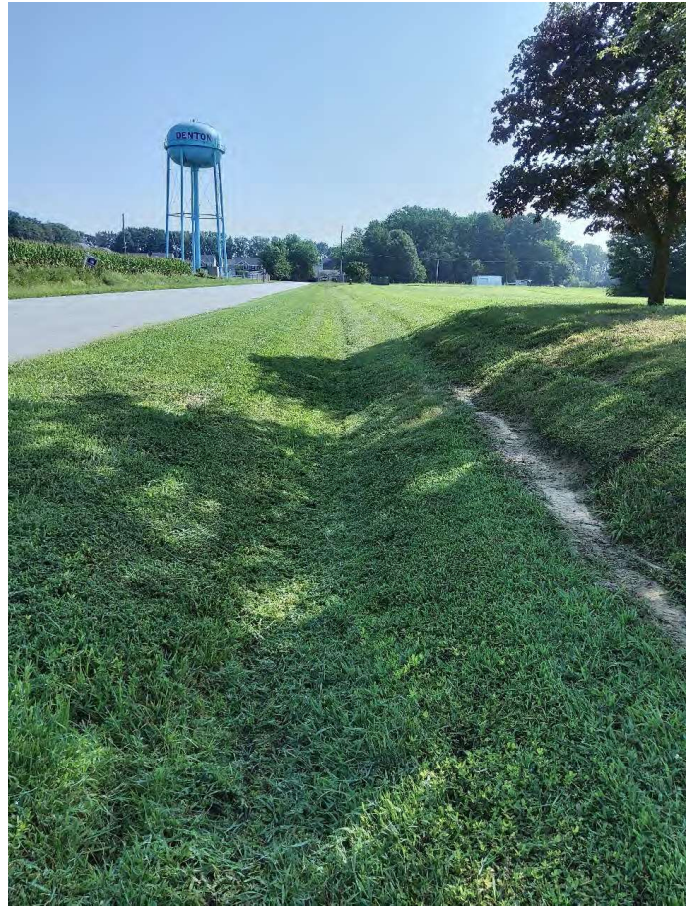
This site is located along Engerman Ave. near the entrance of Furano USA. The existing swale is vegetated with grass and mowed. There are no stormwater features to reduce volume and the grass that is existing does little to address stormwater velocity. The swale could be planted with native vegetation to help increase nutrient uptake and provide some reduction of peak stormwater velocities. The swale could also be upgraded into a bioswale if there is enough room to work in to amend the soils and add small check dams to temporarily pond water.

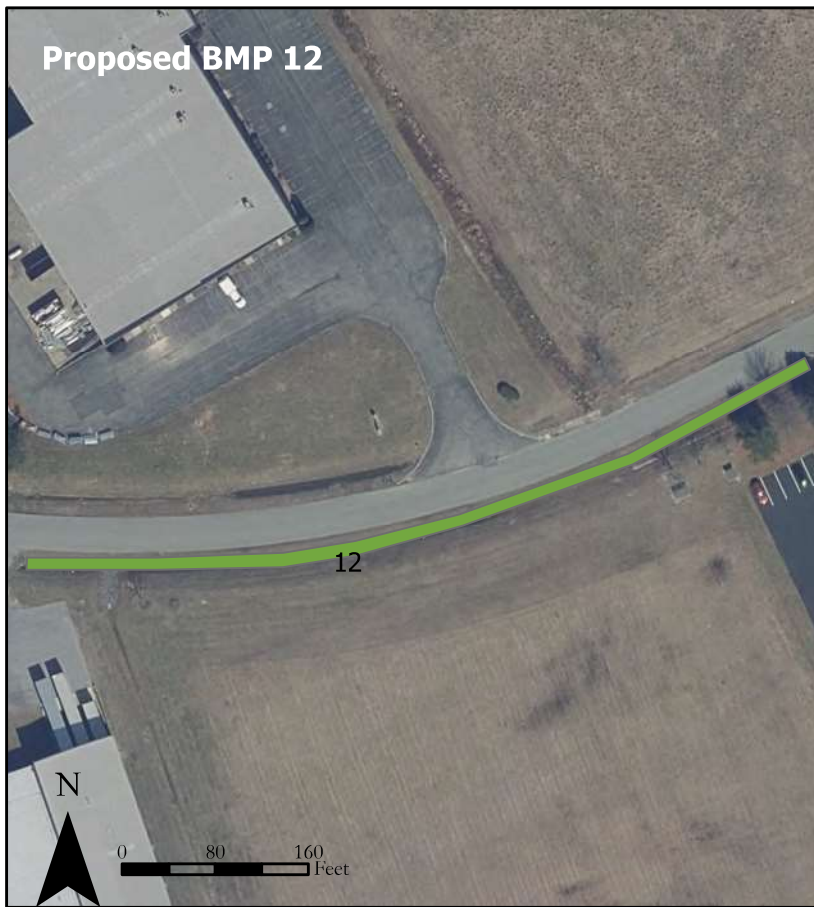
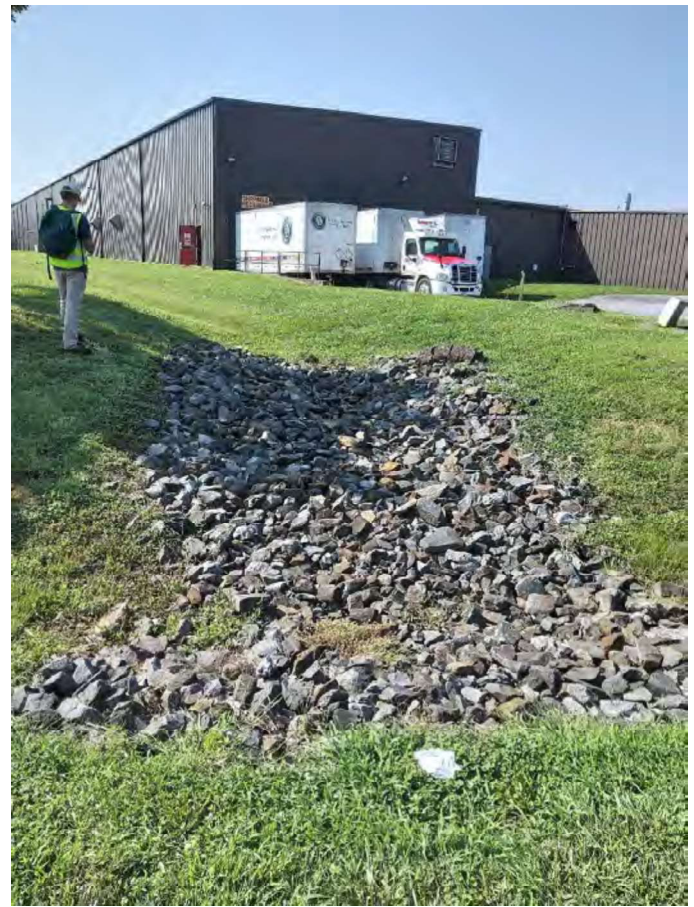
This site is located along Engerman Ave. near the entrance of Unisite Design Inc. The road side swale receives water from a swale that goes along the building pictured above. The existing swale is vegetated with grass and mowed. There are no stormwater features to reduce volume except for rip rap to stabilize one of the swales and the grass that is existing does little to address stormwater velocity. The swale could be planted with native vegetation to help increase nutrient uptake and provide some reduction of peak stormwater velocities. The swale could also be upgraded into a bioswale if there is enough room to work in to amend the soils and add small check dams to temporarily pond water.

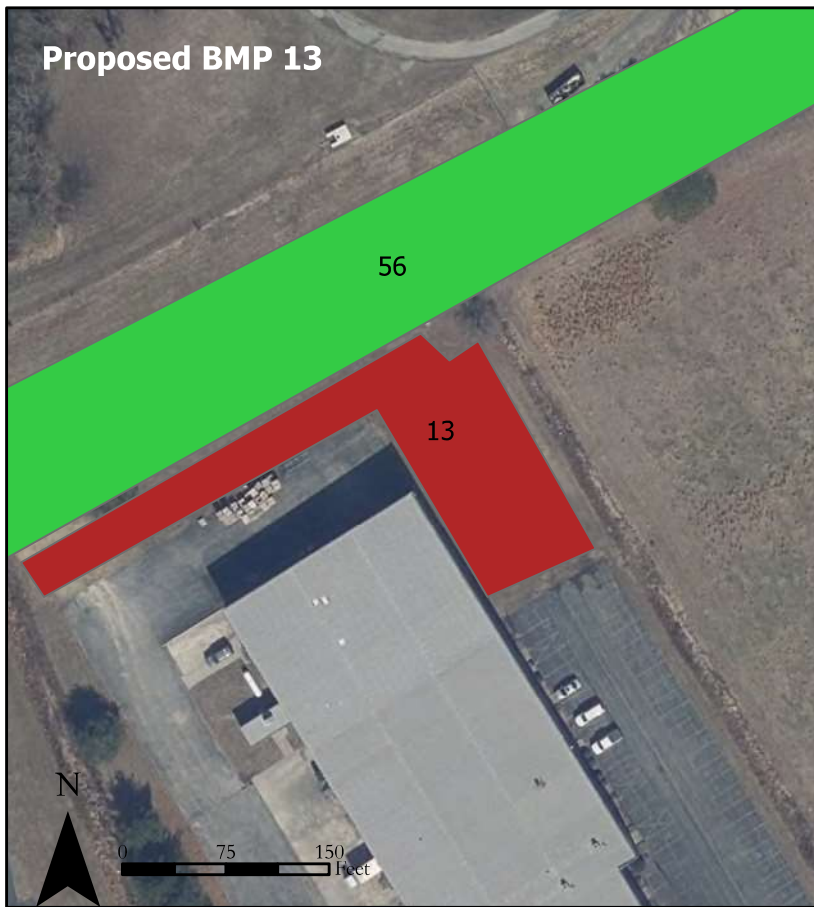
This bioretention site is located along Engerman Ave. at the back of Donovan Marine. This does not include the stream restoration which is a separate project. The area is just a mowed field that abuts the parking lot and a ditch. The building does not have any stormwater facilities but many downspouts that discharge to impervious surfaces. This area provides a good opportunity to treat the runoff from the building and the parking lot by installing a bioretention. The adjacent ditch should also provide an adequate outlet for the bioretention. Other site limitations such as utilities must be investigated further.

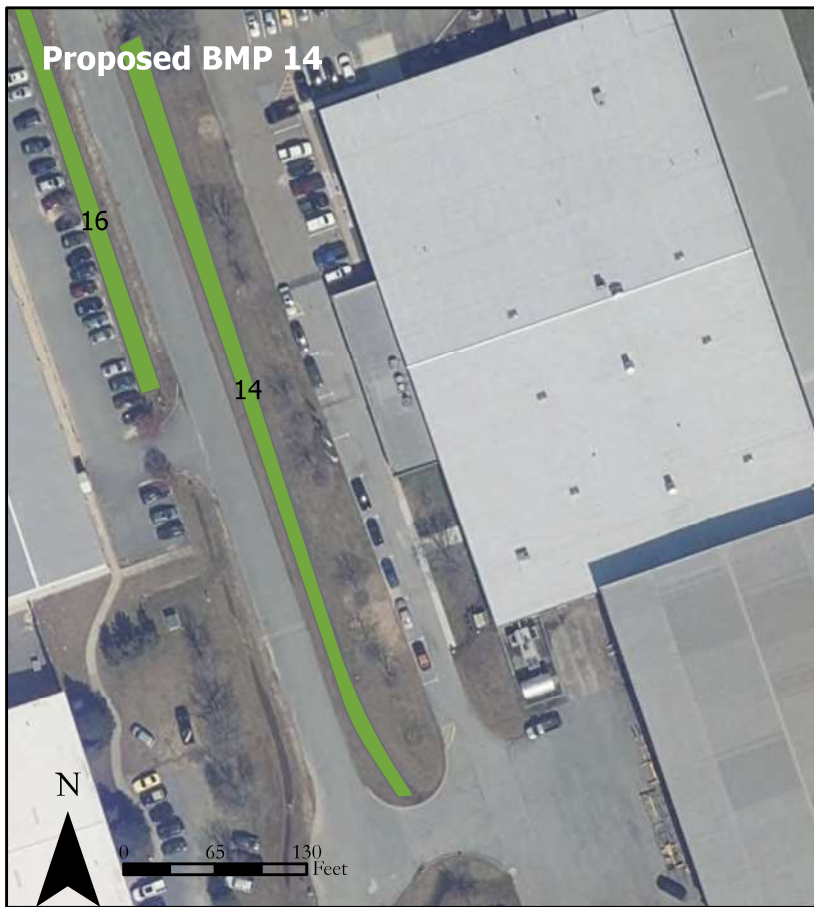
This grass swale is located between Park Ln. and an access road to UniSite design. There the grass swale is within a wide median strip that is mowed and has some landscaping trees. There is very little stormwater retention or attenuation benefit from the grass swale in its present condition. The swale could have native vegetation planted to reduce stormwater velocity and help provide some nutrient treatment as well as habitat value. There is room within the swale and median to create this swale into a bioswale with small check dams to encourage more infiltration to reduce stormwater volume.

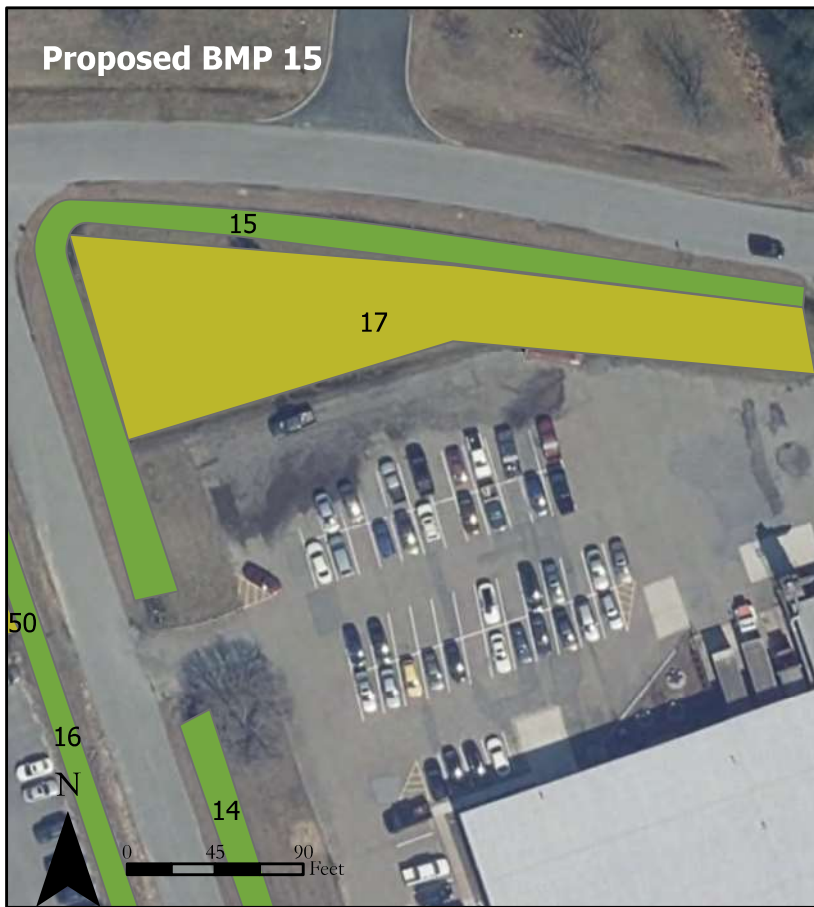
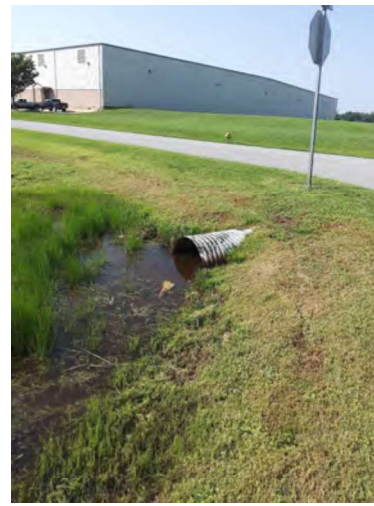
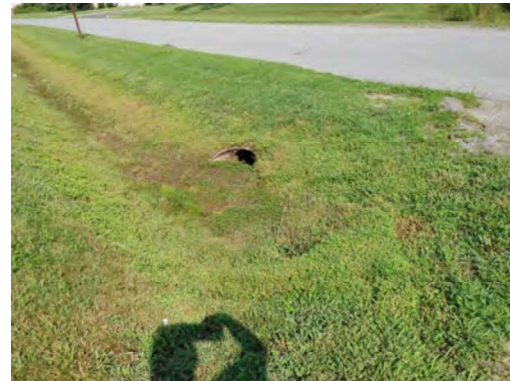
This grass swale is located at the corner of Engerman Ave. and Park Ln. This swale is mowed and currently only has grass growing in it. There is very little stormwater retention or attenuation benefit from the grass swale in its present condition. The swale could have native vegetation planted to reduce stormwater velocity and help provide some nutrient treatment as well as habitat value. If part of the proposed conservation meadow area (BMP 17) is incorporated into the project there could be potential to create a larger bioswale stormwater retention facility.

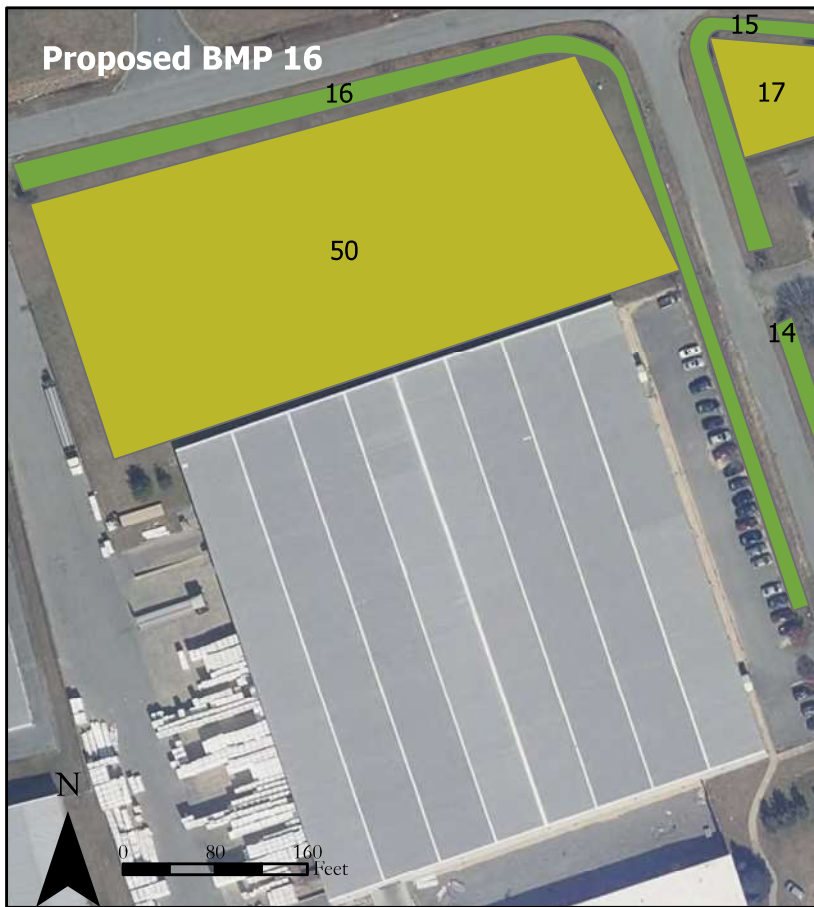
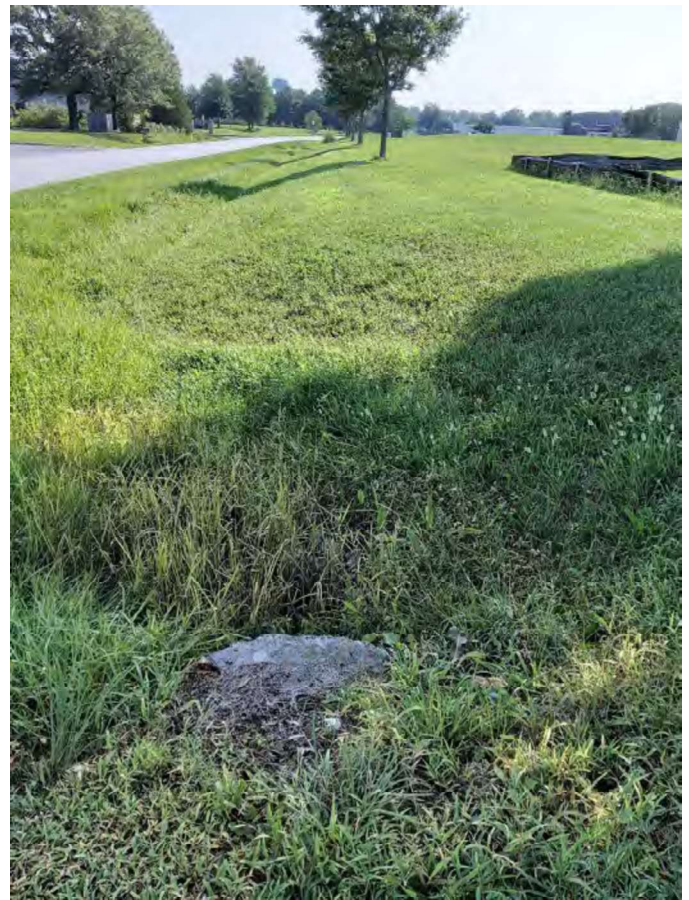
This grass swale is located at the corner of Engerman Ave. and Park Ln. This swale is mowed and currently only has grass growing in it. There is very little stormwater retention or attenuation benefit from the grass swale in its present condition. The swale could have native vegetation planted to reduce stormwater velocity and help provide some nutrient treatment as well as habitat value. If part of the proposed conservation meadow area (BMP 50) is incorporated into the project there could be potential to create a larger bioswale stormwater retention facility.

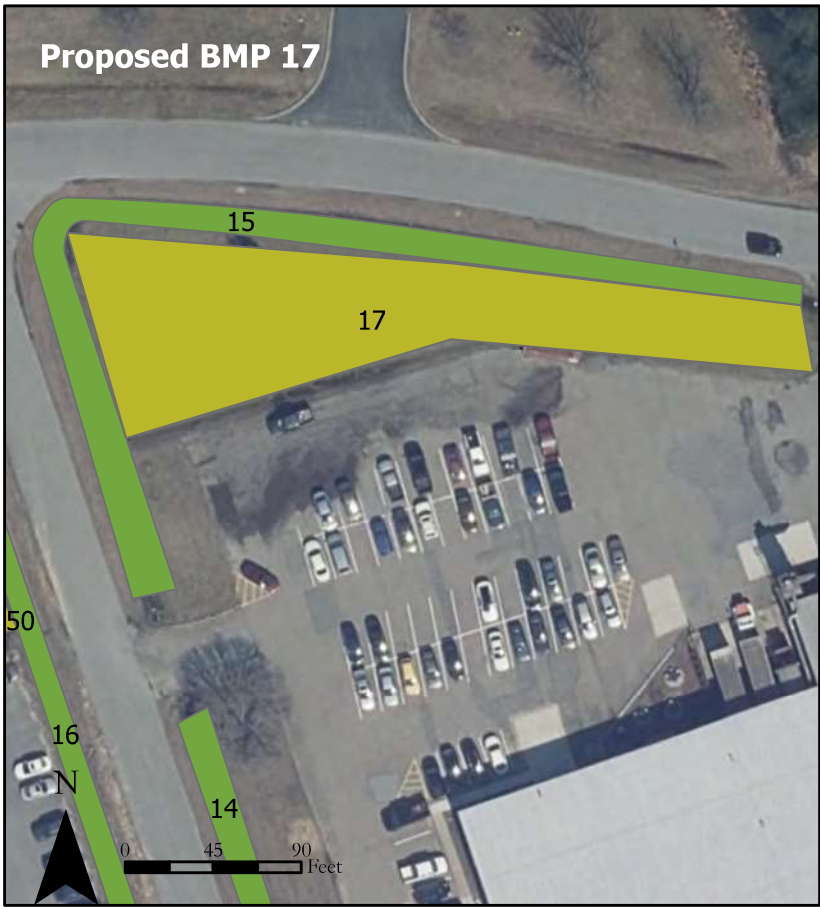
This grassed area is located at the corner of Engerman Ave. and Park Ln. The area is mowed and has a few landscaping trees. This area could be easily converted into a conservation meadow that is planted with native flowering species to create pollinator habitat and provide aesthetic value. The area could also have some trees planted for additional shade and habitat. The addition of more plants to this grassed open space will also help infiltrate more water and provide some stormwater benefit.

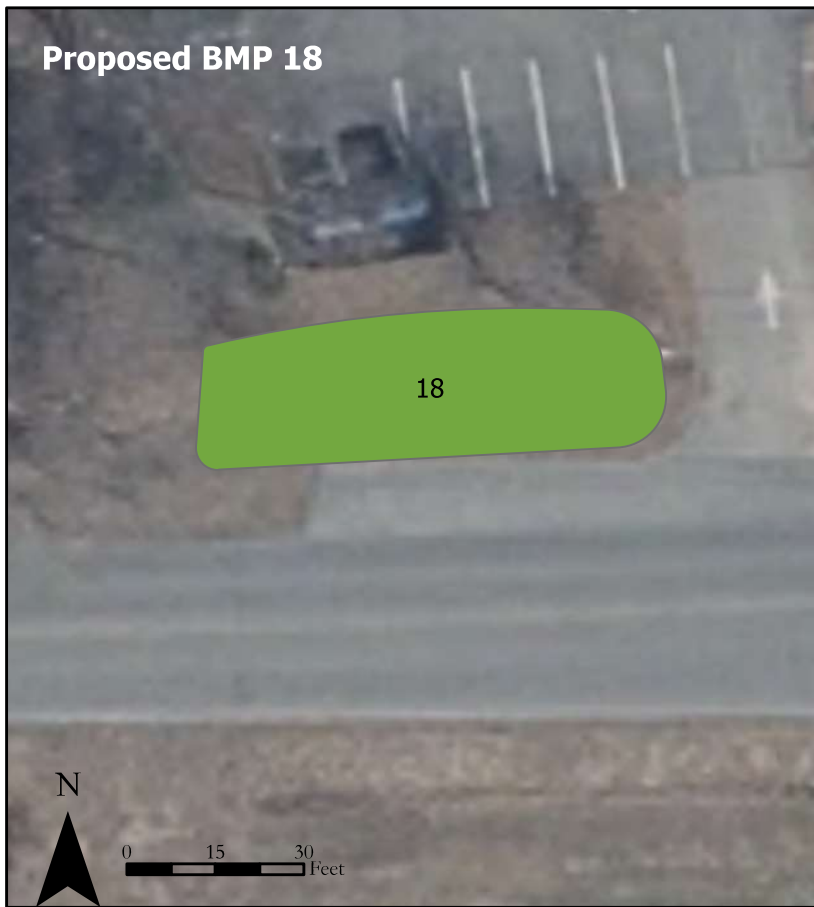
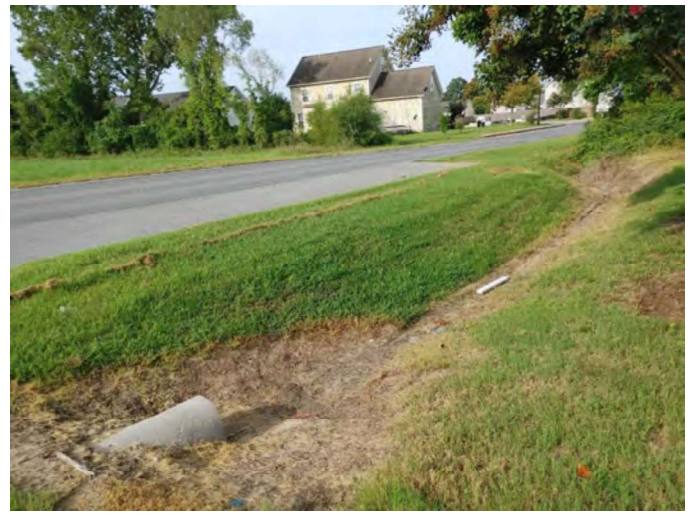
This grass swale is located off of Sharp Rd. near the back entrance to Rent-A-Center and Dollar General. The swale is maintained for conveyance and is mowed and herbicide is also applied to kill vegetation. This provides a very effective stormwater conveyance directly into the ditch. The back entrance was added sometime in 2014 and changed how water moved in this area. Previous to 2014 the grassed swale was larger. There is some room to expand the swale to attenuate some of the stormwater but this project would need to be completed in conjunction with BMP 19 to ensure that the best stormwater outcome can be achieved.

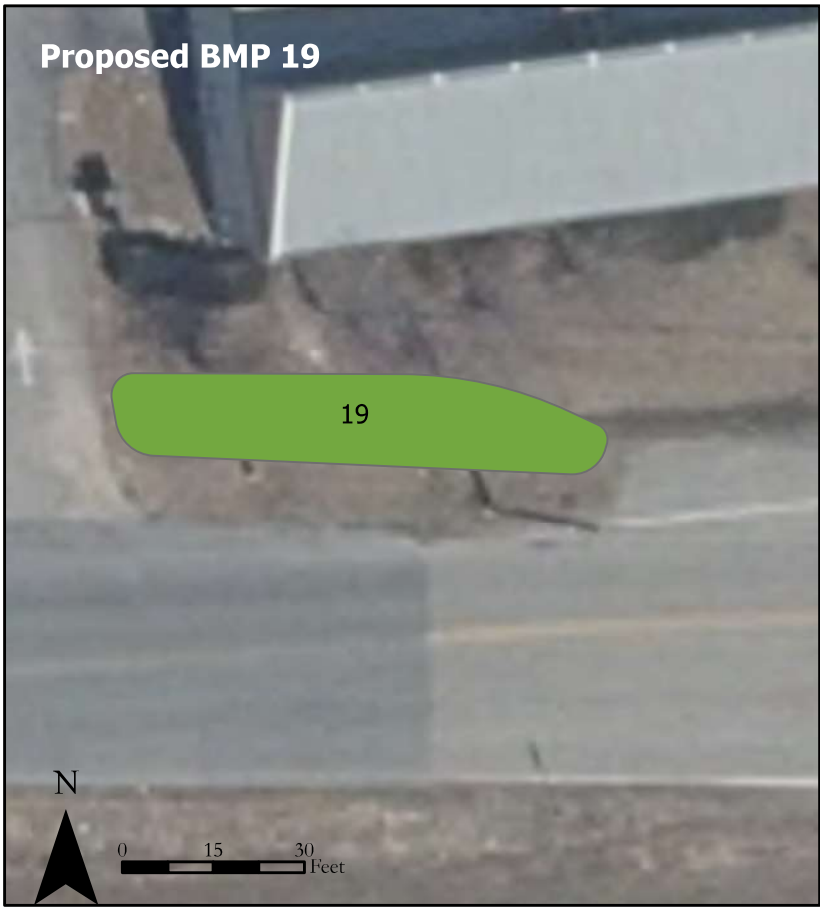
This grass swale is located off of Sharp Rd. near the back entrance to Rent-A-Center and Dollar General. The swale is maintained for conveyance and is mowed and herbicide is also applied to kill vegetation. This provides a very effective stormwater conveyance directly into the ditch. The back entrance was added sometime in 2014 and changed how water moved in this area. Previous to 2014 the grassed swale was larger. There is some room to expand the swale to attenuate some of the stormwater but this project would need to be completed in conjunction with BMP 18 to ensure that the best stormwater outcome can be achieved.

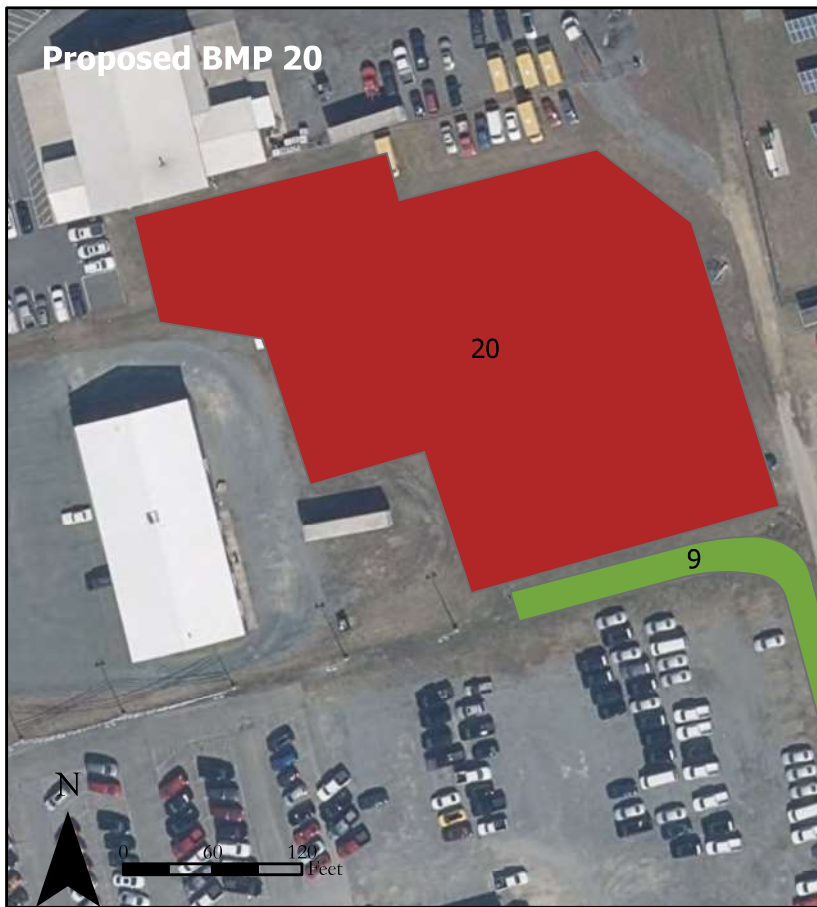
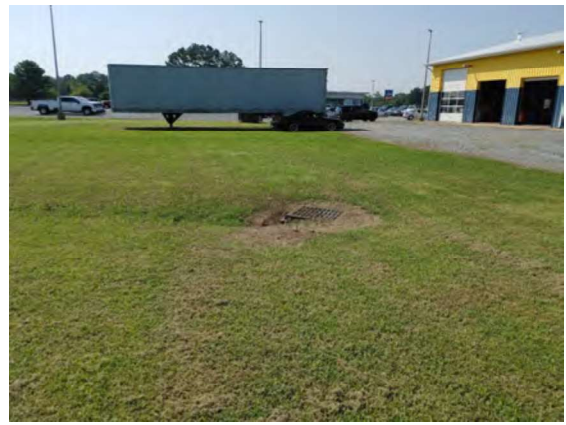
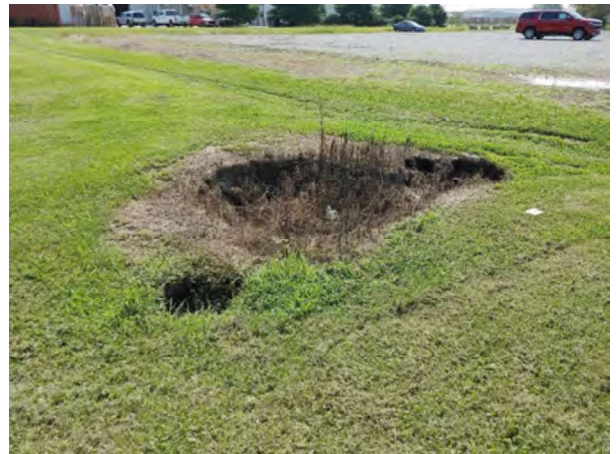
This area is currently grassed and mowed. There appears to be failing drainage infrastructure in the field that might be old agricultural drainage that pre-dates the site. The drainage needs to be inspected to better understand the condition and direction the water flows. Bioretentions could be added to the area to treat runoff from the impervious areas and stormwater from the buildings could be routed to the bioretentions as well. If the drainage that is existing is in good enough shape the bioretentions can be designed to drain into that system.
