# Poor House Run Hydrologic Assessment and Watershed Action Plan

April 1, 2022

## Appendix A: Project Sites and Estimated Nutrient and Sediment Reductions

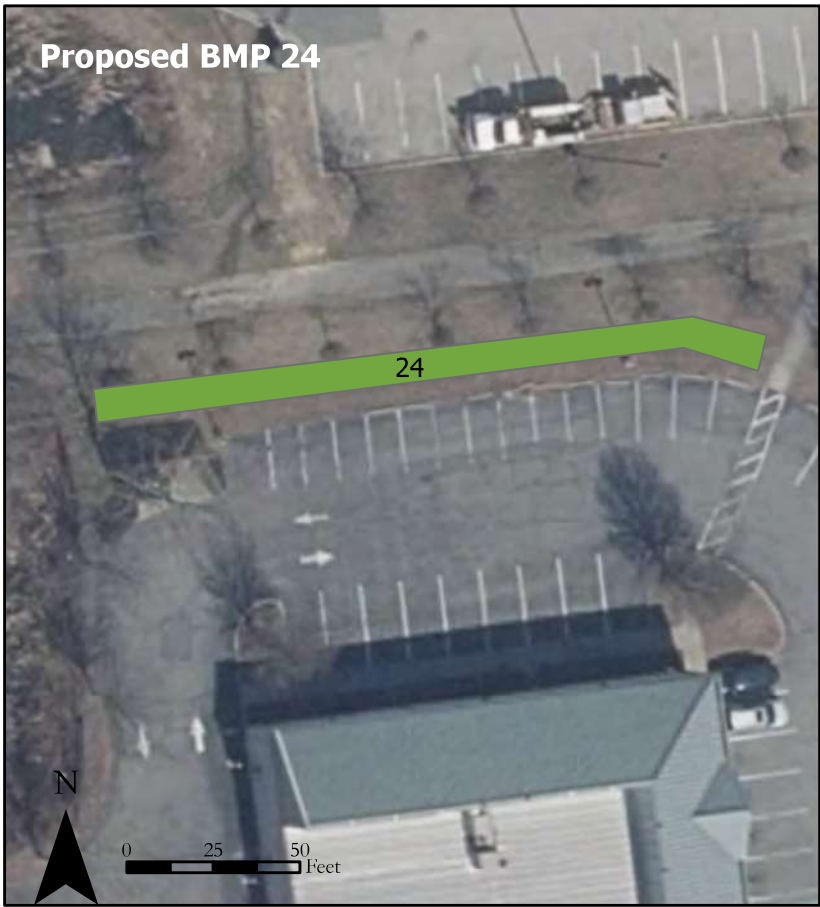
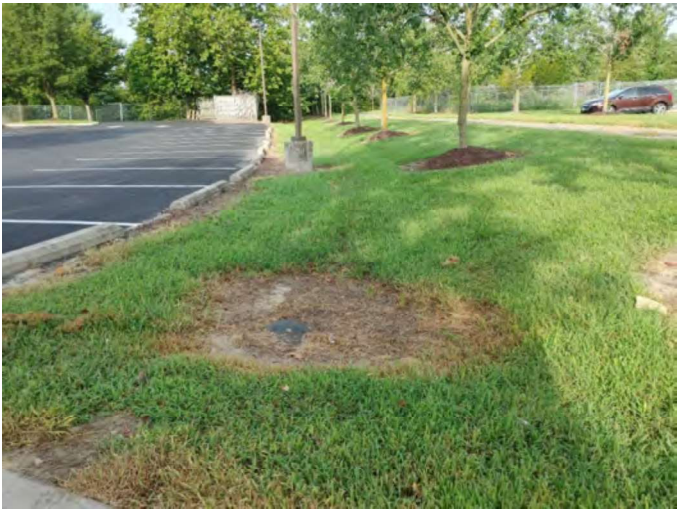
This site is located on the north side of the Dollar General Parking lot. The existing swale is vegetated with grass and mowed. There are no stormwater features to reduce volume and the grass that is existing does little to address stormwater velocity. The swale could be planted with native vegetation to help increase nutrient uptake and provide some reduction of peak stormwater velocities. The swale could also be upgraded into a bioswale if there is enough room to work in to amend the soils and add small check dams to temporarily pond water.

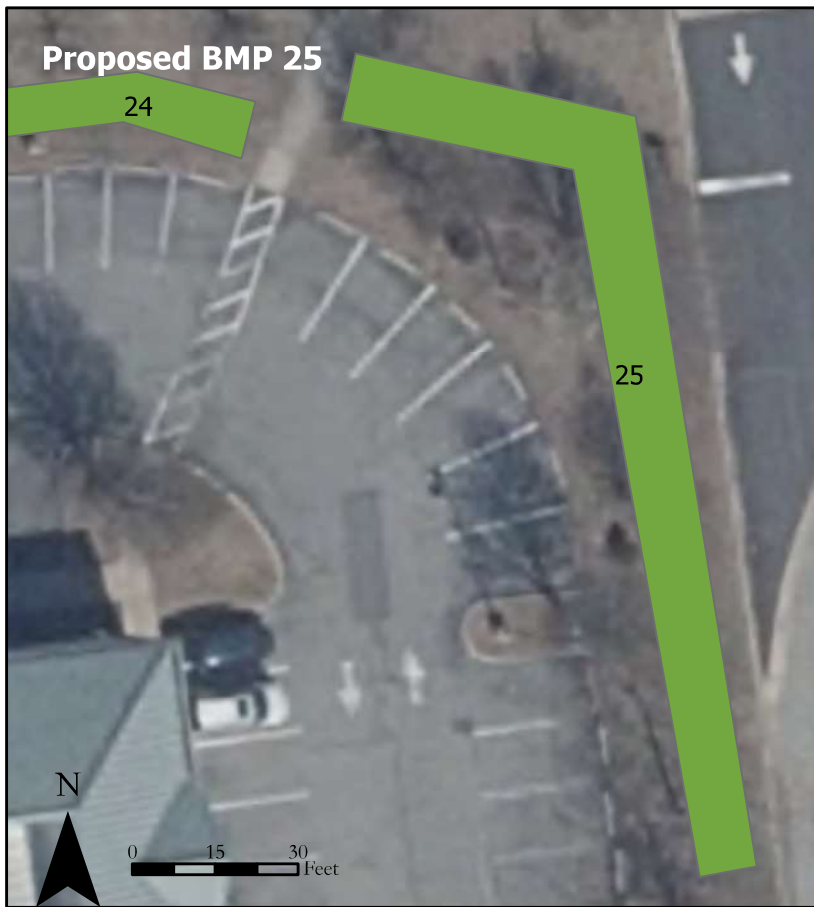
This site is located on the northeast side of the Dollar General Parking lot. The existing swale is vegetated with grass and mowed and there are some landscaping trees. There are no stormwater features to reduce volume and the grass that is existing does little to address stormwater velocity. The swale could be planted with native vegetation to help increase nutrient uptake and provide some reduction of peak stormwater velocities. The swale could also be upgraded into a bioretention if there is enough room to work in to amend the soils.

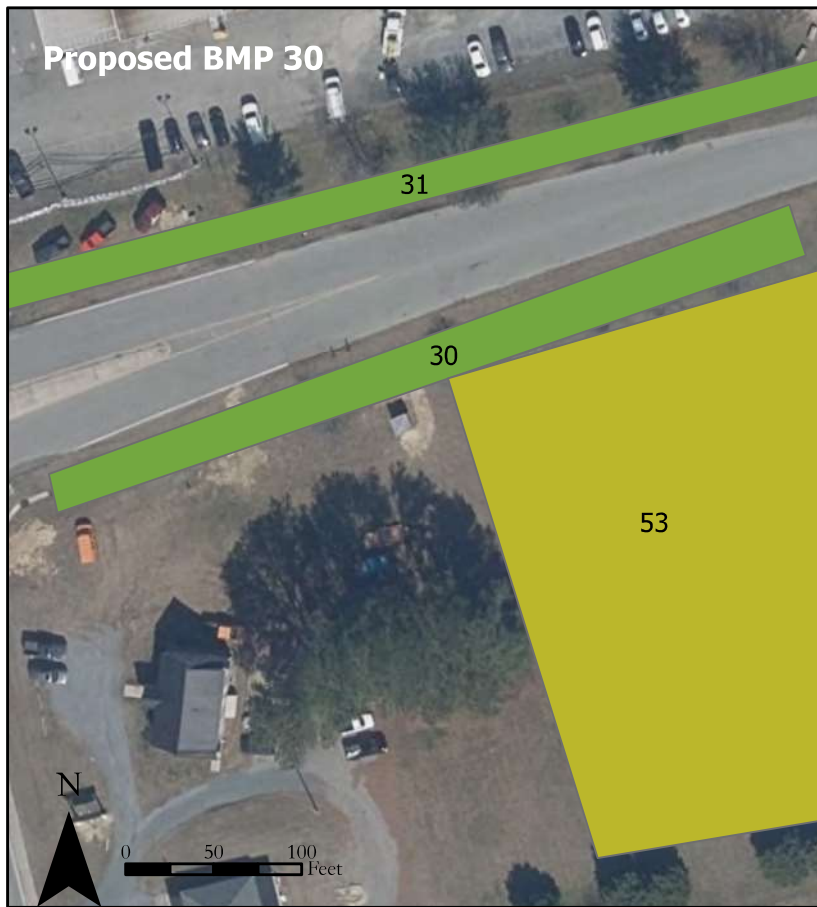
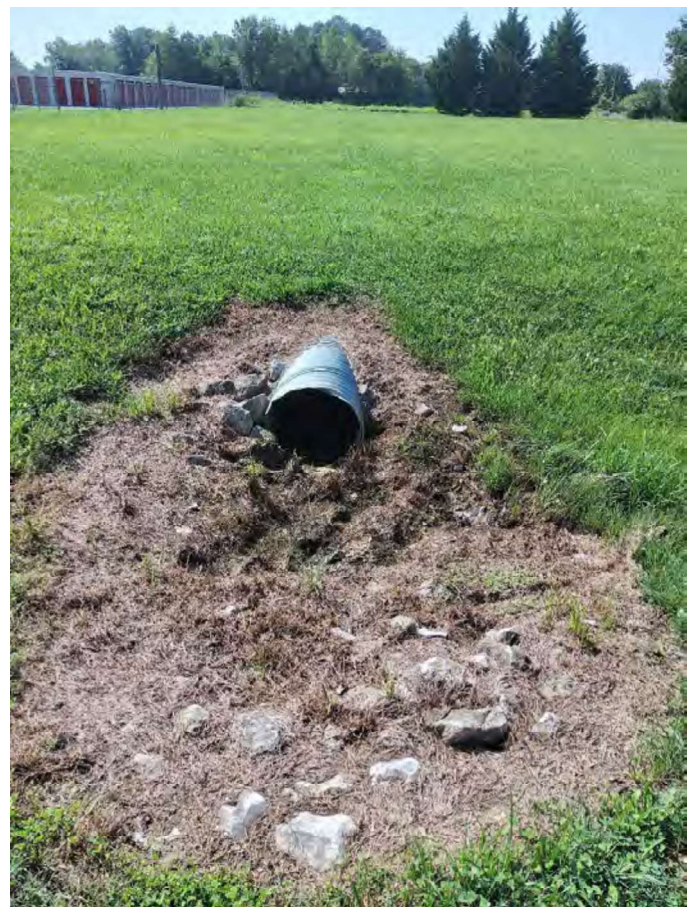
This site is located at the south side of the intersection of Engerman Ave. and Industrial Parkway. The existing swale is vegetated with grass and receives drainage from a pipe that (top right) that drains the storage facility. There are no stormwater features to reduce volume and the grass that is existing does little to address stormwater velocity. The swale could be planted with native vegetation to help increase nutrient uptake and provide some reduction of peak stormwater velocities. The swale could also be retrofitted into a bioswale with small check dams to provide some stormwater retention and infiltration. Implementing a bioswale at this location would require more site investigation of soils and utilities. Working with the private landowners there might be an opportunity to daylight the pipe and create a stormwater facility in the grassed field.

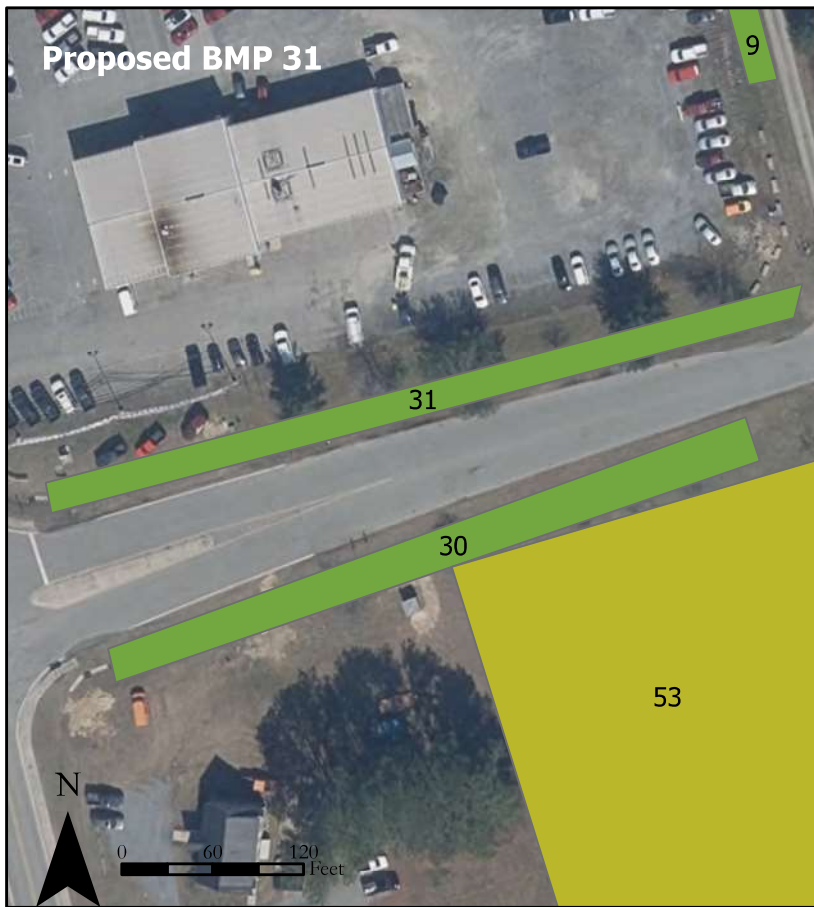
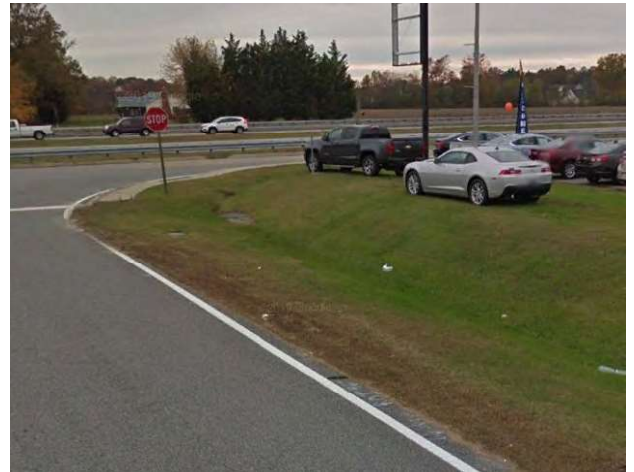
This site is located at the north side of the intersection of Engerman Ave. and Industrial Parkway. The existing swale is vegetated with grass and mowed and there are some landscaping trees. There are no stormwater features to reduce volume and the grass that is existing does little to address stormwater velocity. The swale could be planted with native vegetation to help increase nutrient uptake and provide some reduction of peak stormwater velocities. The swale could also be retrofitted into a bioswale with small check dams to provide some stormwater retention and infiltration. Implementing a bioswale at this location would require more site investigation of soils and utilities.

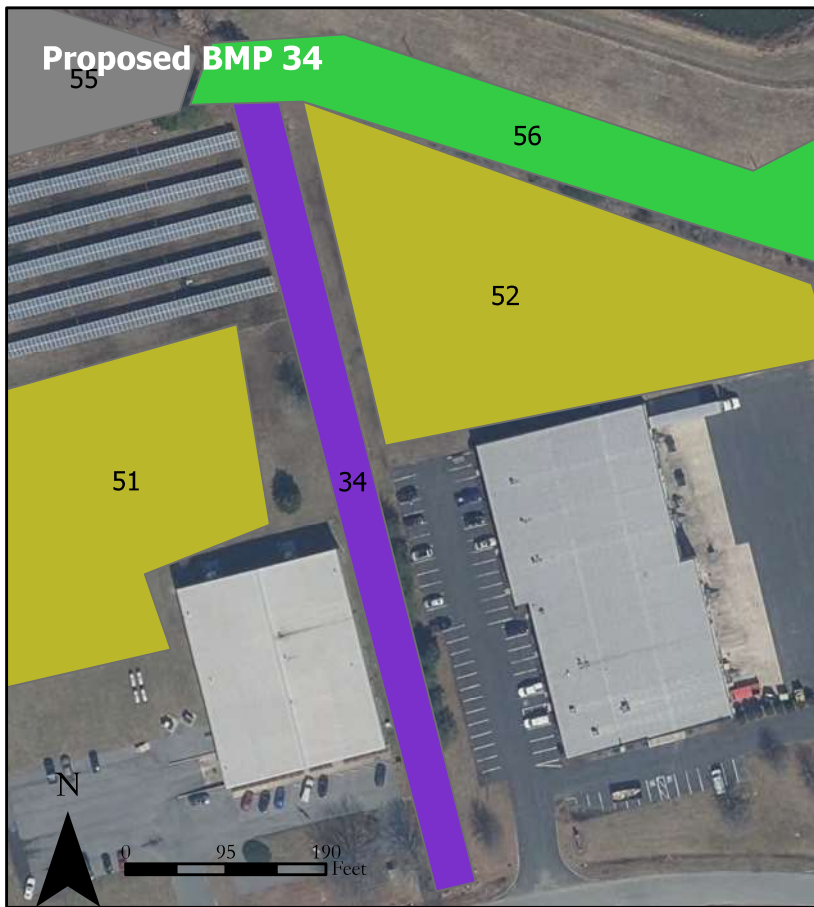
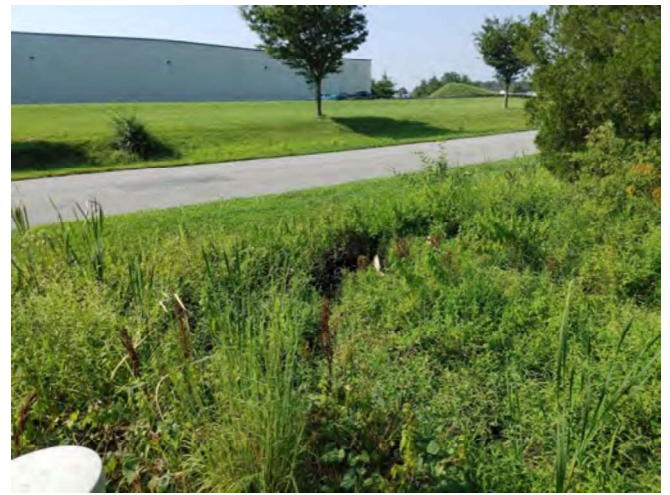
This site is located off Engerman Ave. between Palmetto factory and Lorry Industries. The present condition of the site is an overgrown ditch that conveys stormwater from two roadside swales and revives water from the two adjacent properties. The ditch does seem to receive periodic maintenance. The site is a good candidate for a stormwater facility, with a bioswale making the most sense. There should be few limitations at the site and access is good. There might be space to create a larger stormwater facility if both the landowners are amenable to providing some space on their properties.

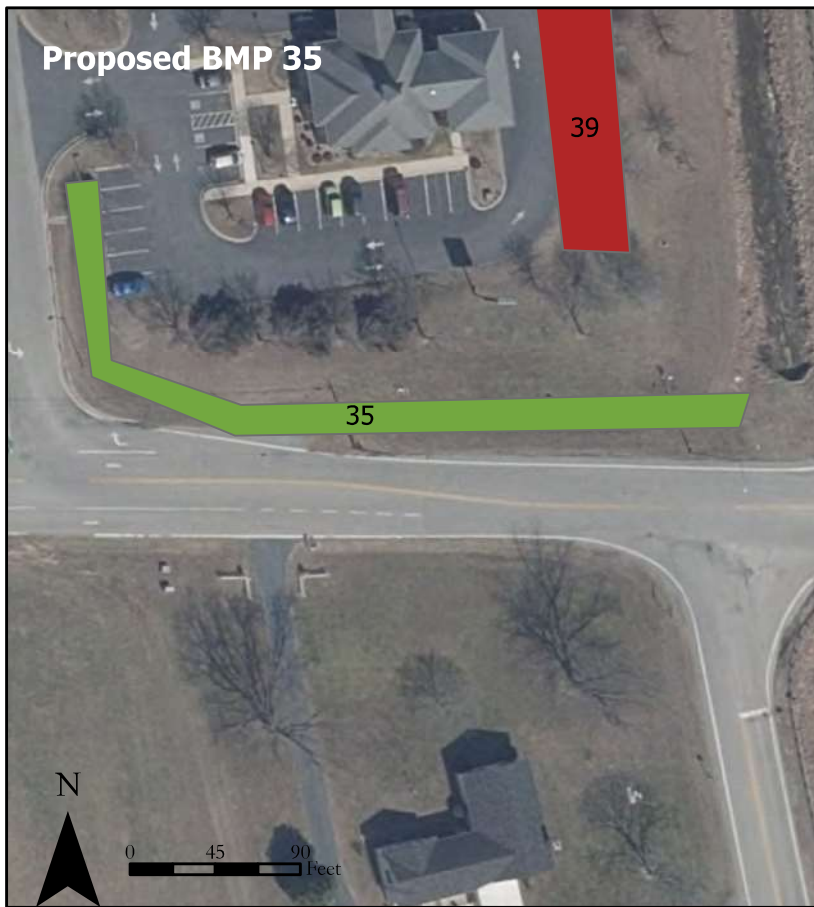
This site is located on the south side of Shore United Bank adjacent to Sharp Rd. The existing swale is vegetated with grass and mowed and there are some landscaping trees. The swale drains to a roadside ditch along 404. There are no stormwater features to reduce volume and the grass that is existing does little to address stormwater velocity. The swale could be planted with native vegetation to help increase nutrient uptake and provide some reduction of peak stormwater velocities. The swale could also be upgraded into a bioretention/bioswale if there is enough room to work in to amend the soils and if there are no conflicts with utility right of way.

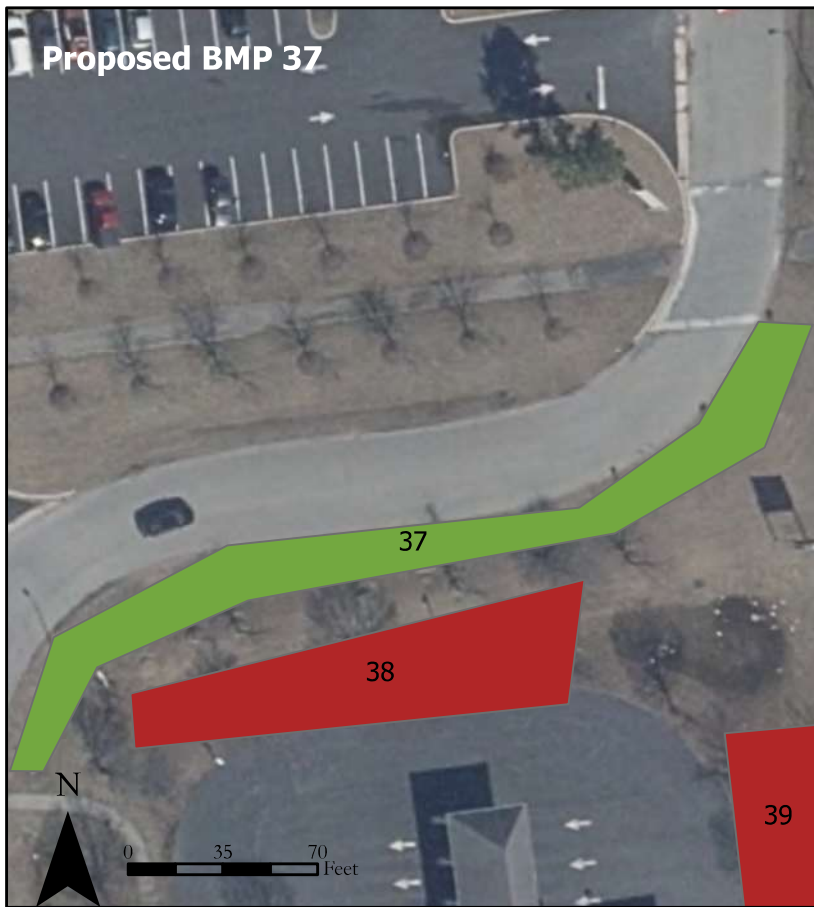
This site is located on the north side of Shore United Bank adjacent to 5th St. The swale is mowed grass and has a few landscaping trees. There are no stormwater features to reduce volume and the grass that is existing does little to address stormwater velocity. The swale could be planted with native vegetation to help increase nutrient uptake and provide some reduction of peak stormwater velocities. The swale could also be upgraded into a bioswale if there is enough room to work in to amend the soils.

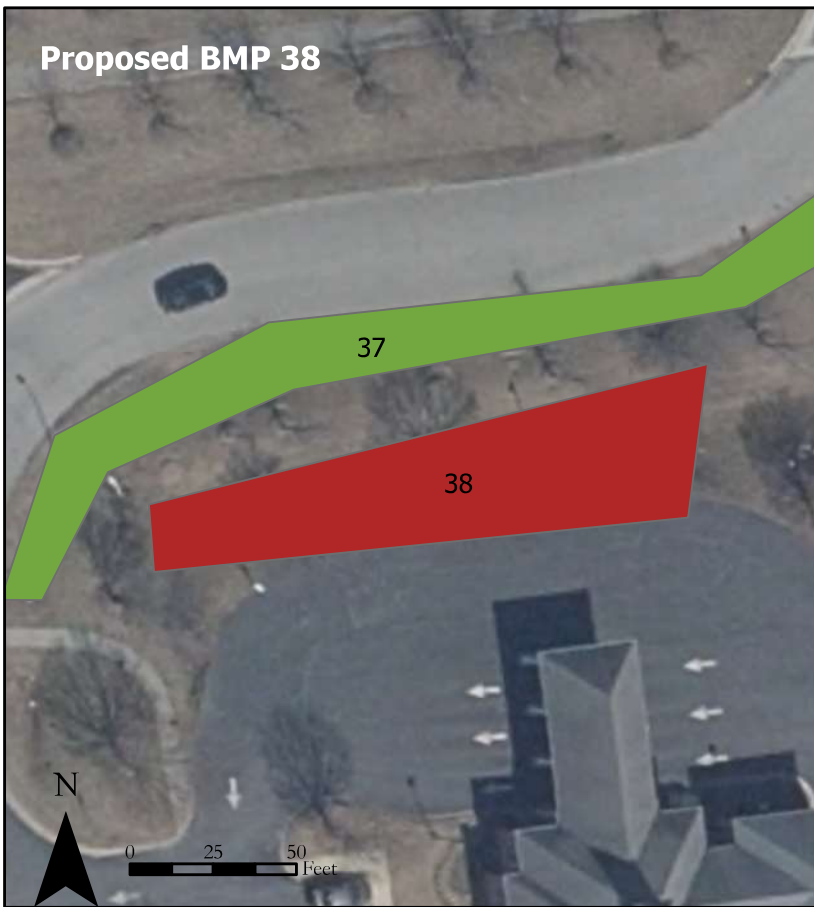
This site is located on the north side of Shore United Bank adjacent to 5th St. The swale is mowed grass and has a few landscaping trees. There are no stormwater features to reduce volume and the grass that is existing does little to address stormwater velocity. The swale could be designed to be a bioretention area that is able to store and infiltrate stormwater. Further down the swale another bioretention or small stormwater facility could be added were there is an existing storm drain inlet (BMP 39).

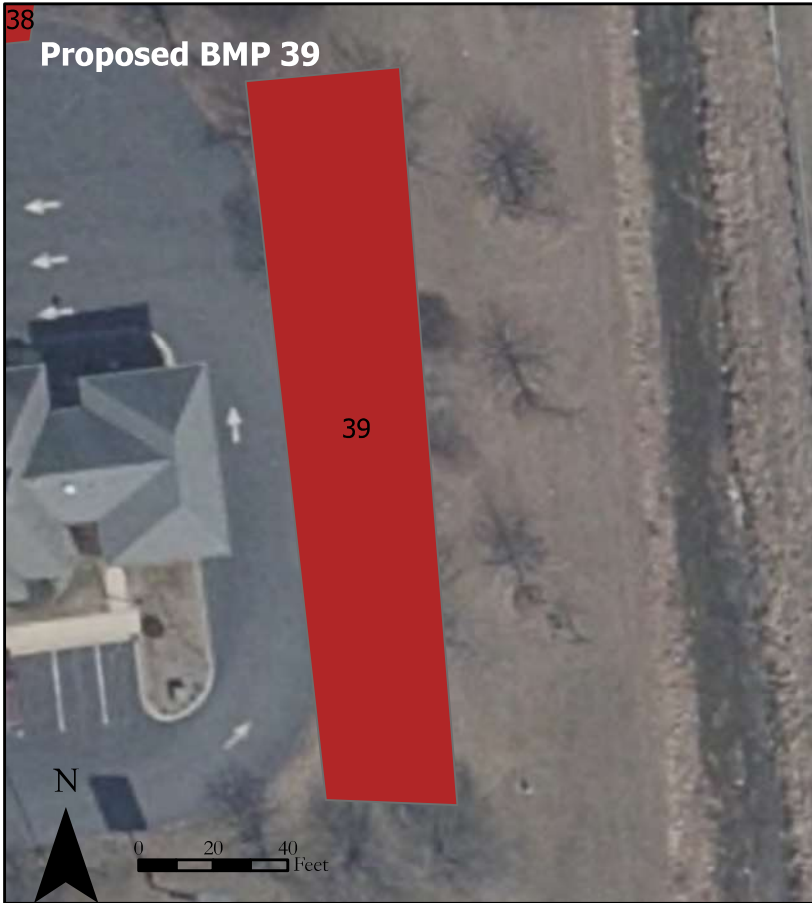
This site is located on the east side of Shore United Bank. The swale is mowed grass and has a few landscaping trees. There are no stormwater features to reduce volume and the grass that is existing does little to address stormwater velocity. The swale could be designed to be a bioretention area that is able to store and infiltrate stormwater.

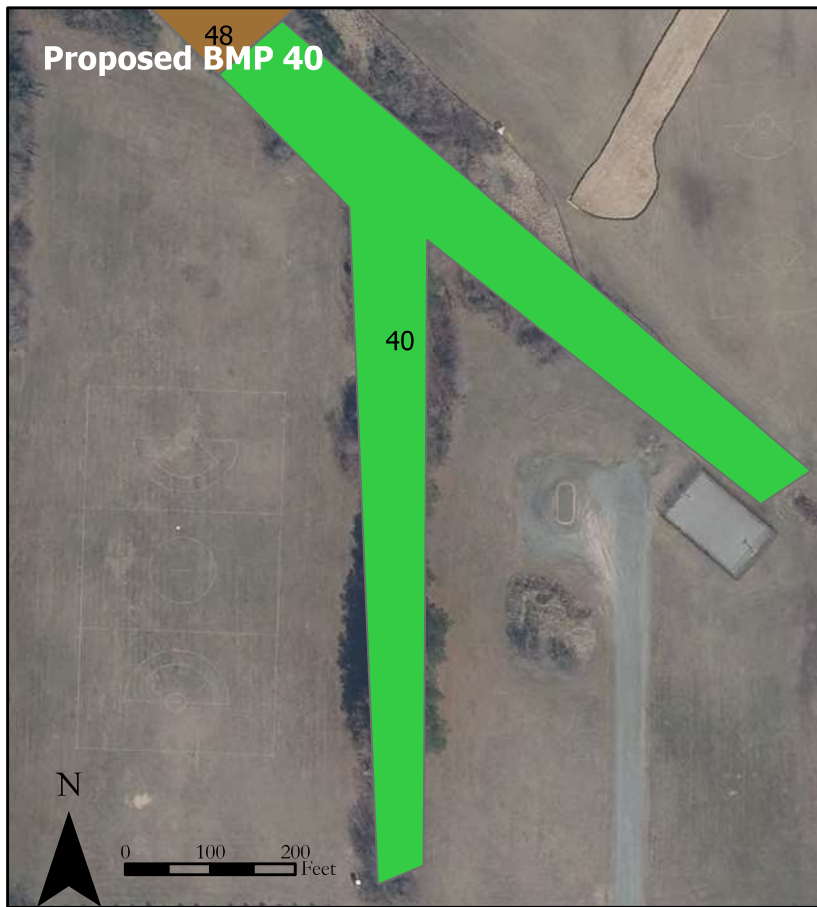
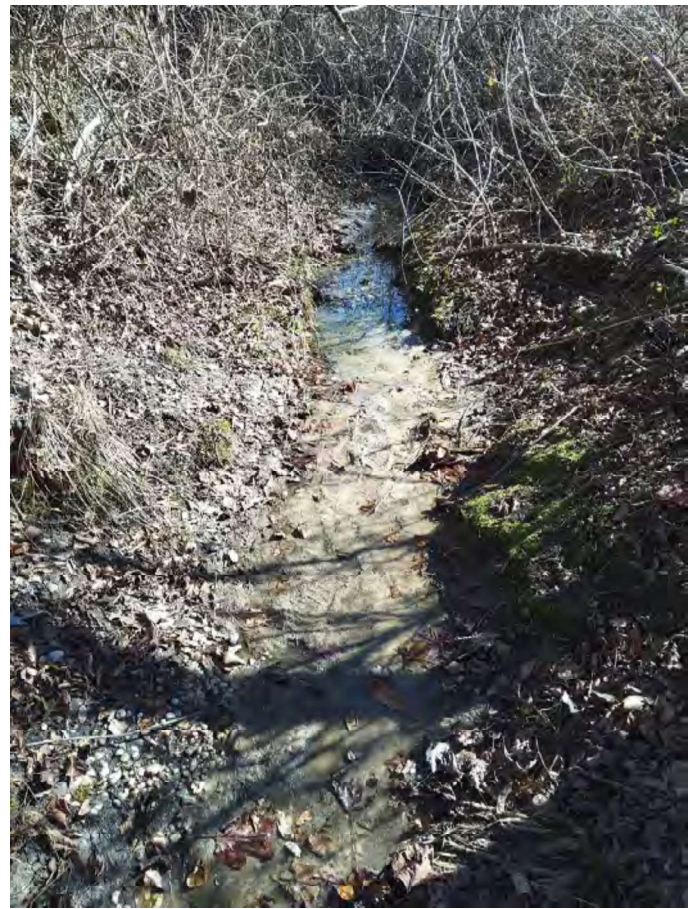
This site is located in Sharp Road Community Park. This project is part of the larger Poor House Run stream restoration project. The ditches that go through the park are incised with some erosion. The restoration methods that could be completed in the ditches could be to turn the ditch into a "swamp run" were the ditches are widened and wetland vegetation is able take hold. This will allow water to still be conveyed but allows for retention and peak flow attenuation. Some of the park grounds would need to be used to complete a restoration using this method. If using park ground is an issue the project could be confined more in channel with natural channel methods used to help stabilize the banks and better handle storm flows.

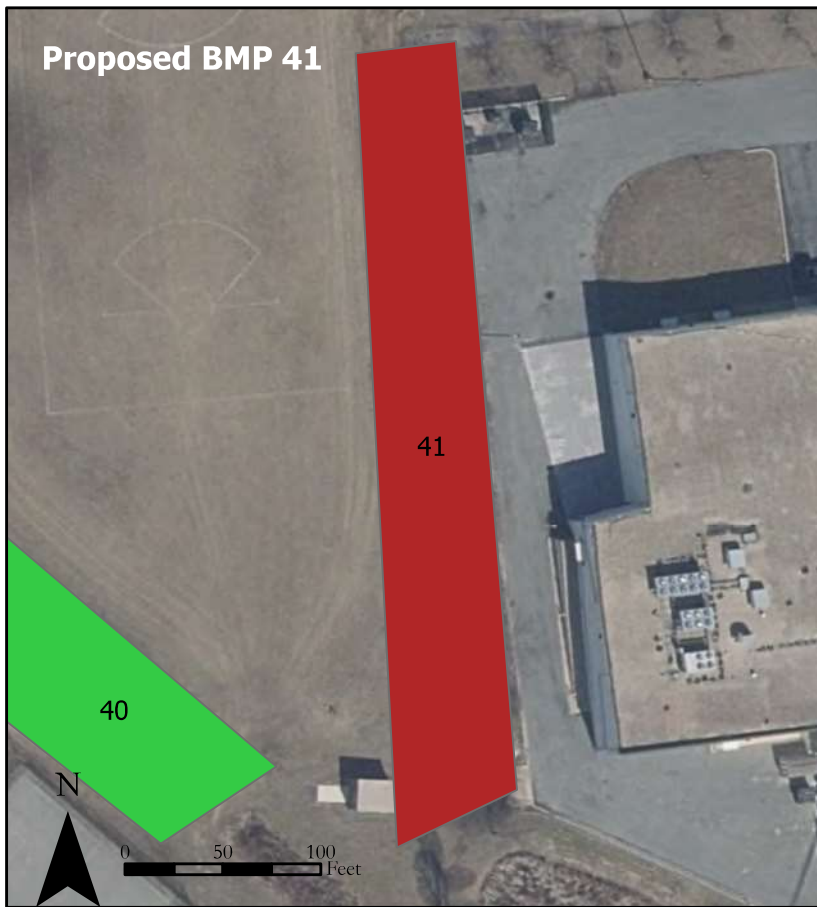
This site is located at the back of Food Lion and in Sharp Road Community Park . The impevious area drains into a stormwater pond at the south end of the proposed bioretention. Working with the town and the private landowner a bioretention could be designed to help store and treat stormwater before it goes into the stormwater pond.

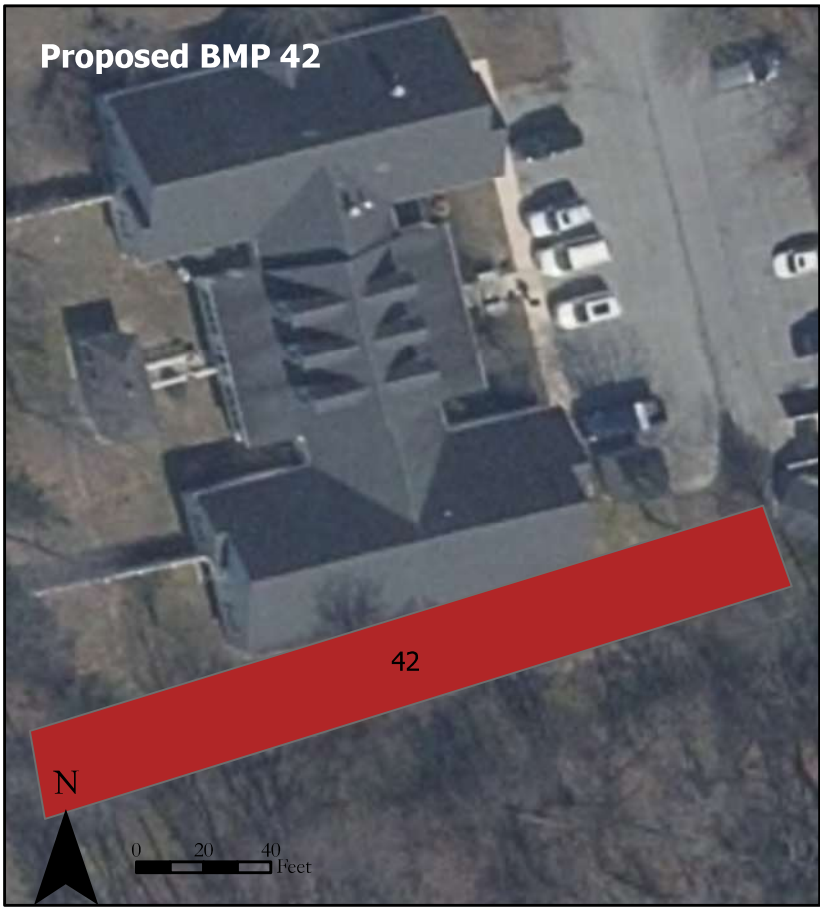
This site is located at Arcadia of Denton and outlets to 5th St. There is an existing old stormwater practice that could be re-designed to meet current practice standards for bioretentions.

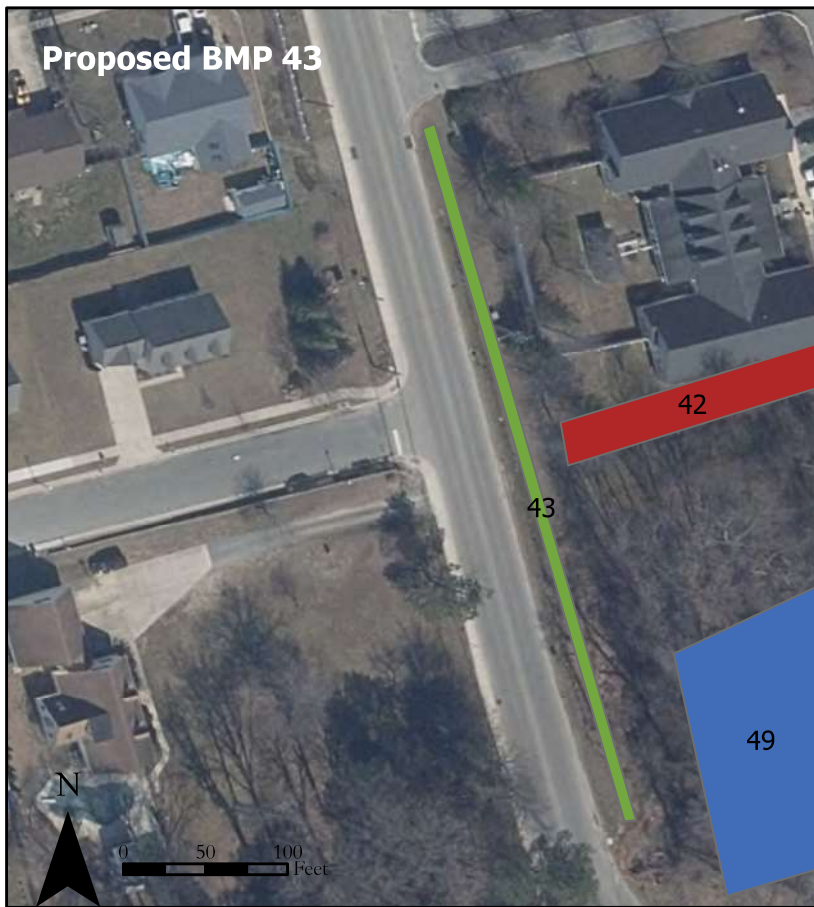
This site is located along 5th St. The swale is grassed and mowed. The swale drains directly to the north culvert that carries the norther tributary of Poor House Run and goes under 5th St. There might be some room between the road and the forest to put in a linear stormwater feature to reduce peak stormwater flow going down into the culvert. There might be opportunity to divert this flow into the forest to better treat and store stormwater. This BMP might be able to tie into BMP 49.

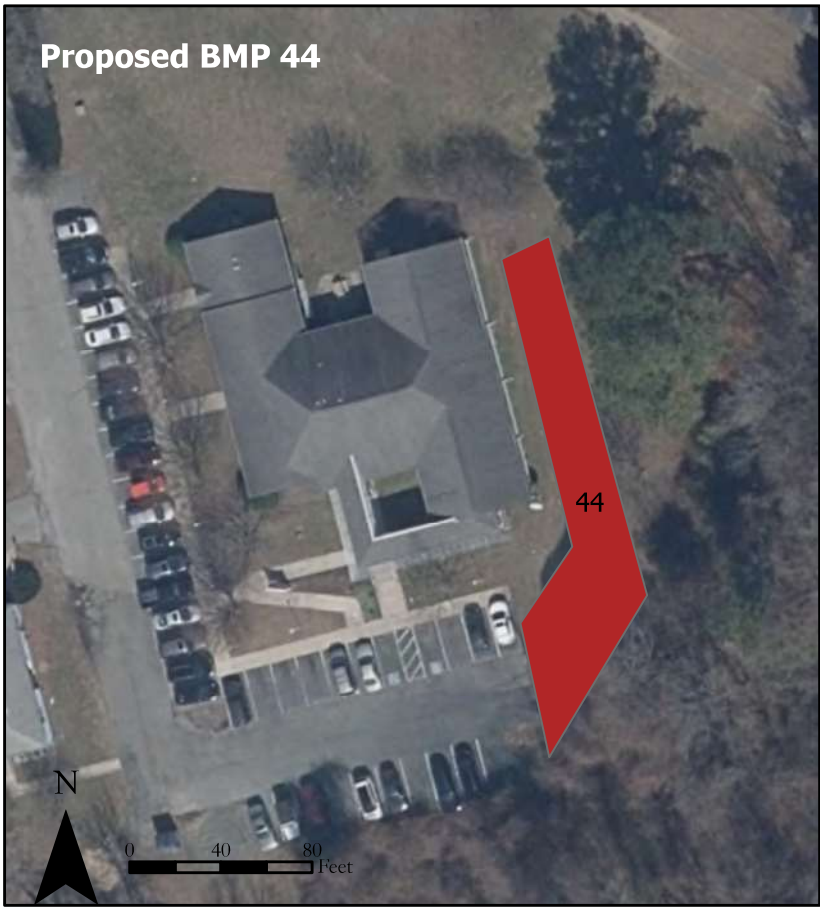
This site is located at Denton Medical Center on Daffin Ln. There is an existing old stormwater practice that could be re-designed to meet current practice standards for bioretentions.

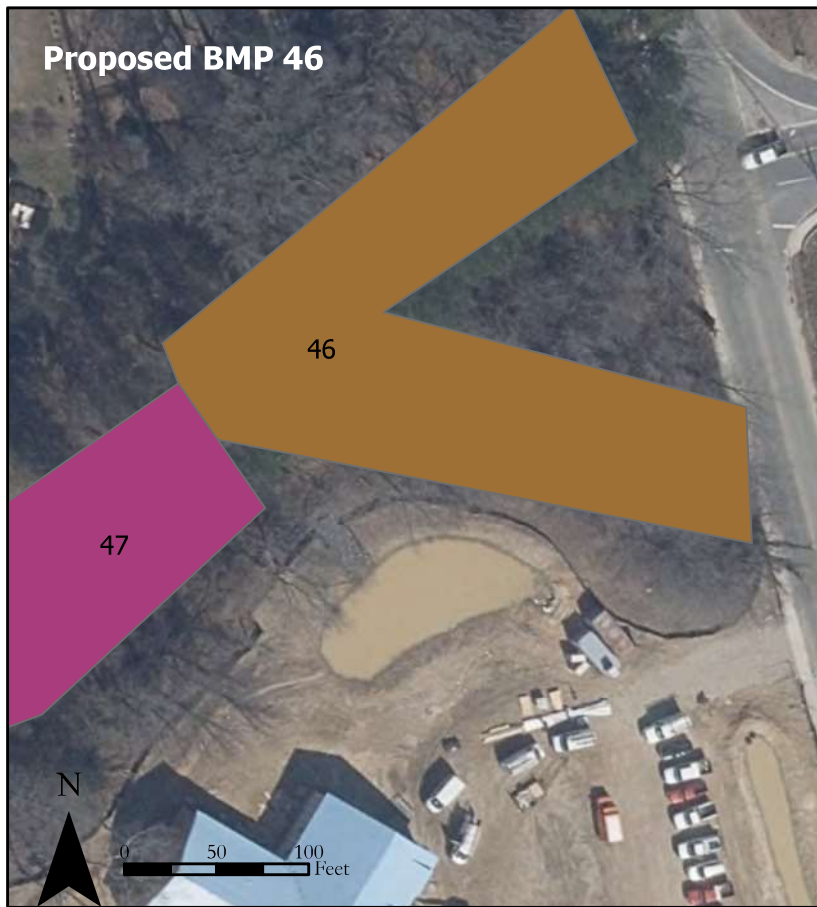
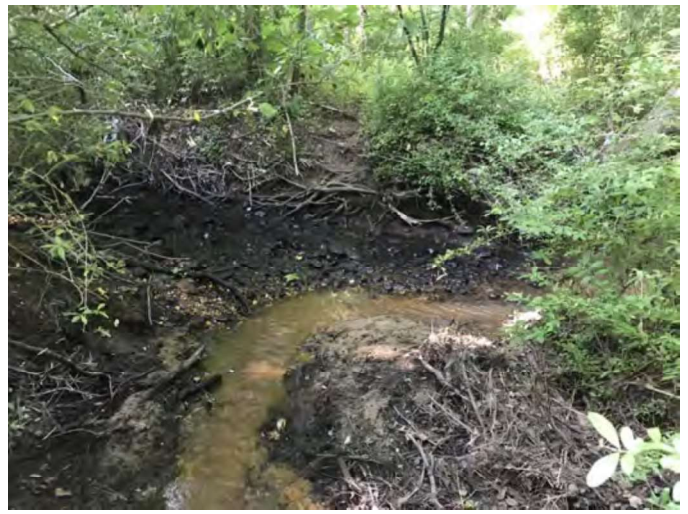
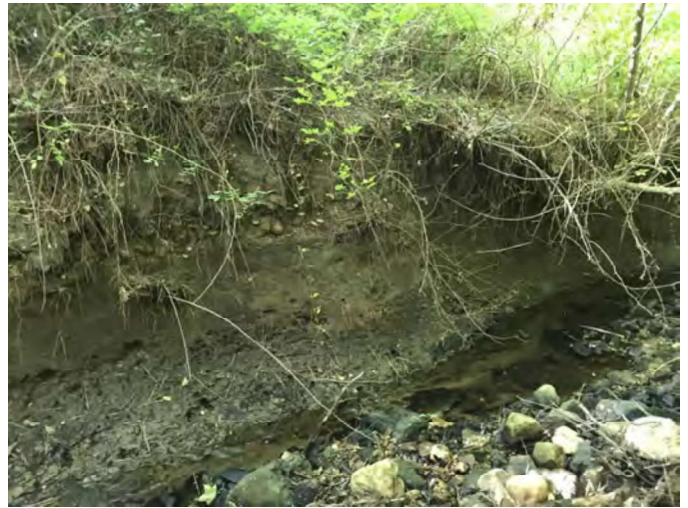
This site is located at 5th St. and comprises both culverts that pass on 5th St. The stream restoration for Poor House Run in this section will need a regenerative stormwater conveyance design to help step water down a steep grade in a manner that is not erosive and helps stabilize the stream banks. This portion of the of Poor House Run stream restoration should be completed at the same time as the culvert replacement to ensure proper access and reduce traffic issues in the area.

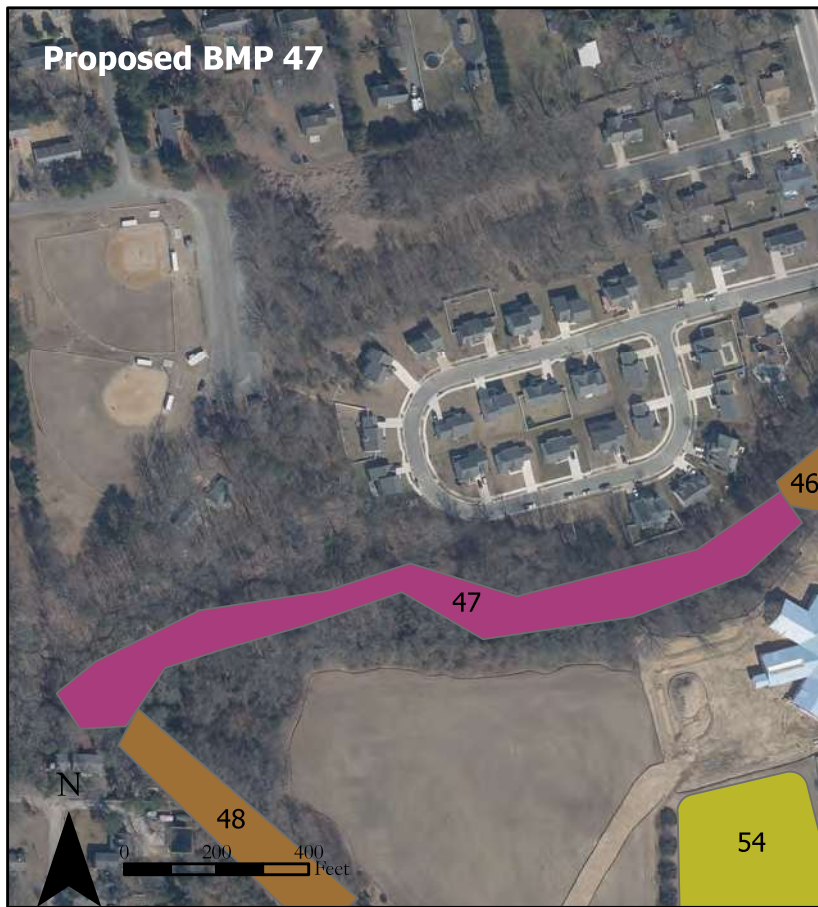
This site is along the Poor House Run stream corridor. This part of the stream is relatively stable but disconnected from the floodplain. Natural channel design that uses soft engineering (wood and small structures) could be used to help reconnect the floodplain to help with flood attenuation. The stream restoration design needs to be designed to account for future changes in the watershed that could increase peak stream discharge during storm events.

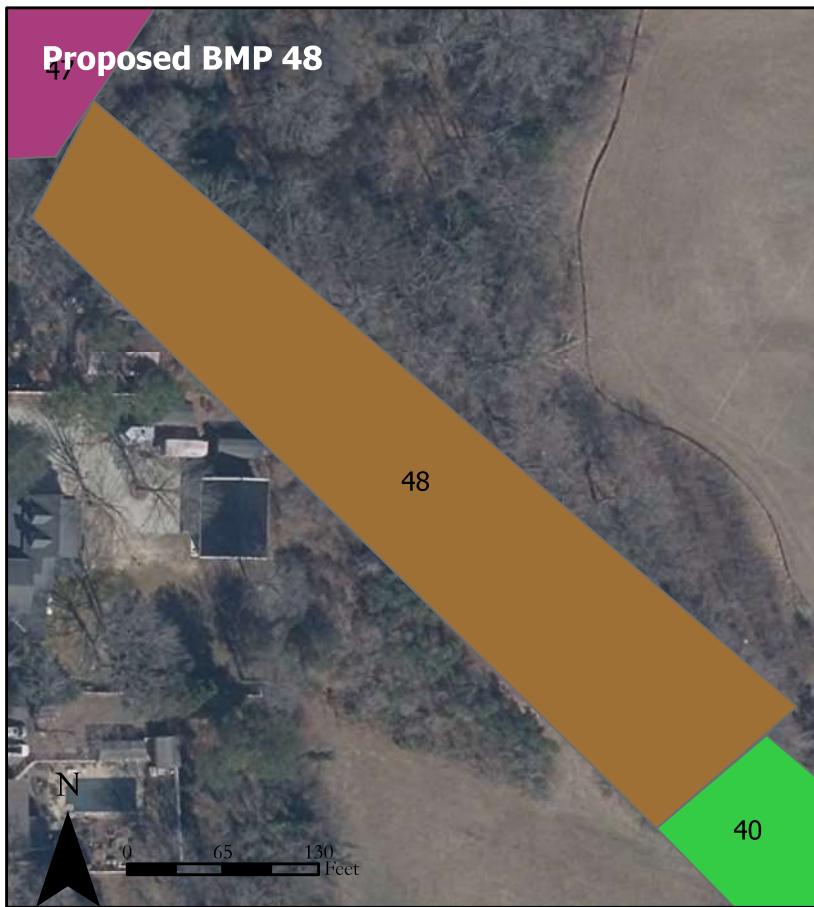
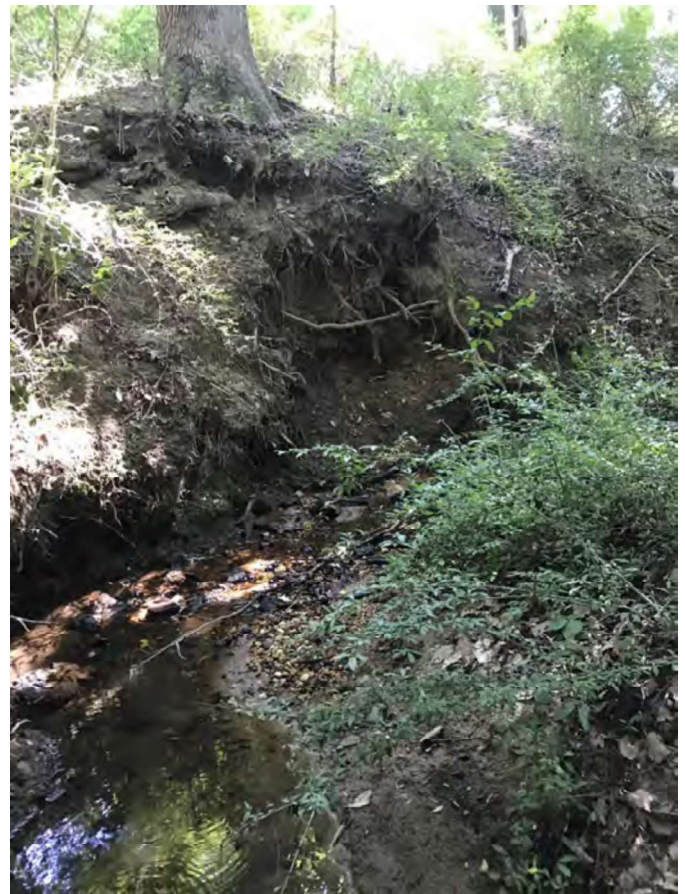
This site is located in the ditch that cuts through Sharp Road Community Park. The end of the ditch before it connects with Poor House Run is severely eroded and unstable. Regenerative stormwater conveyance (RSC) methods need to be used to help step water down the steep grade. RSC use step pools to stair-step water down a steep grade in a way that maintains channel stability and encourages some water to infiltrate to reduce stormwater volume.

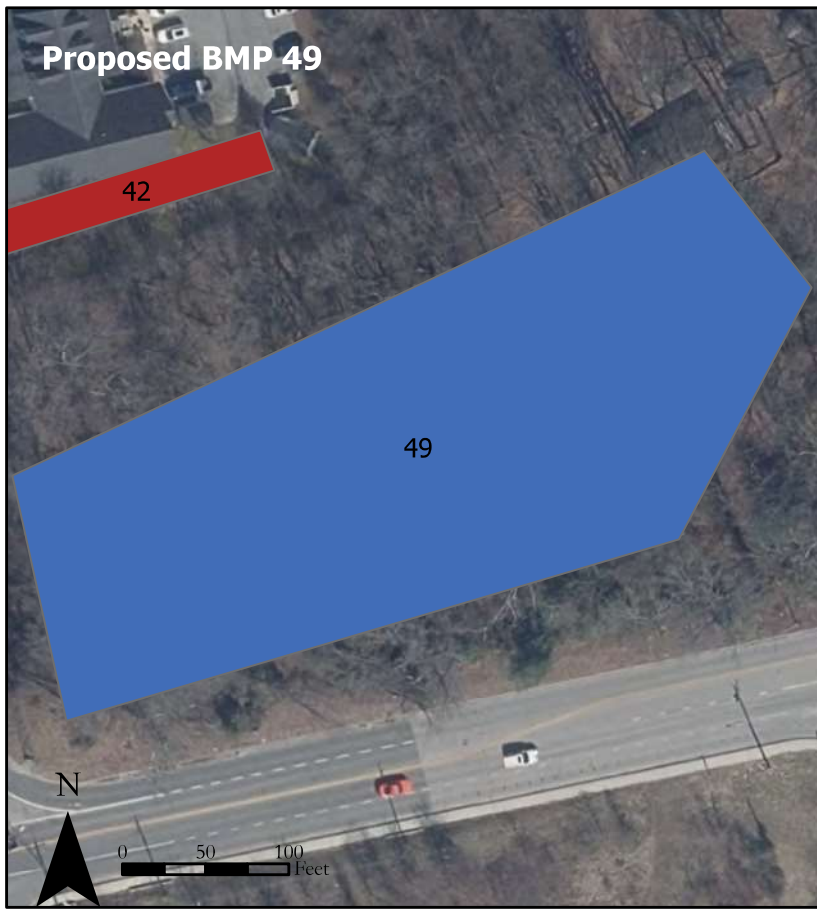
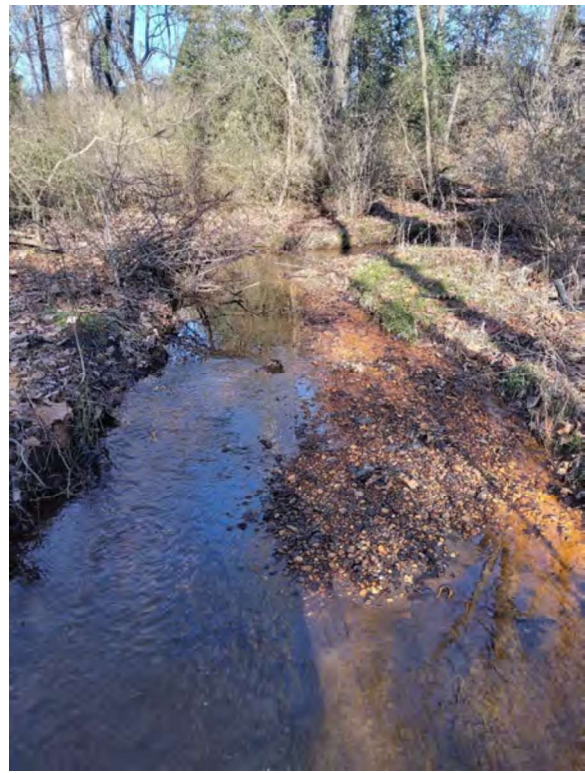
This site is located at 5th St. and Legion Rd. and is the north tributary of Poor House Run. This area could be designed to better handle stormwater to reduce peak discharge and alleviate some pressure on the culverts and downstream sections of Poor House Run. This land is owned by the Town of Denton.

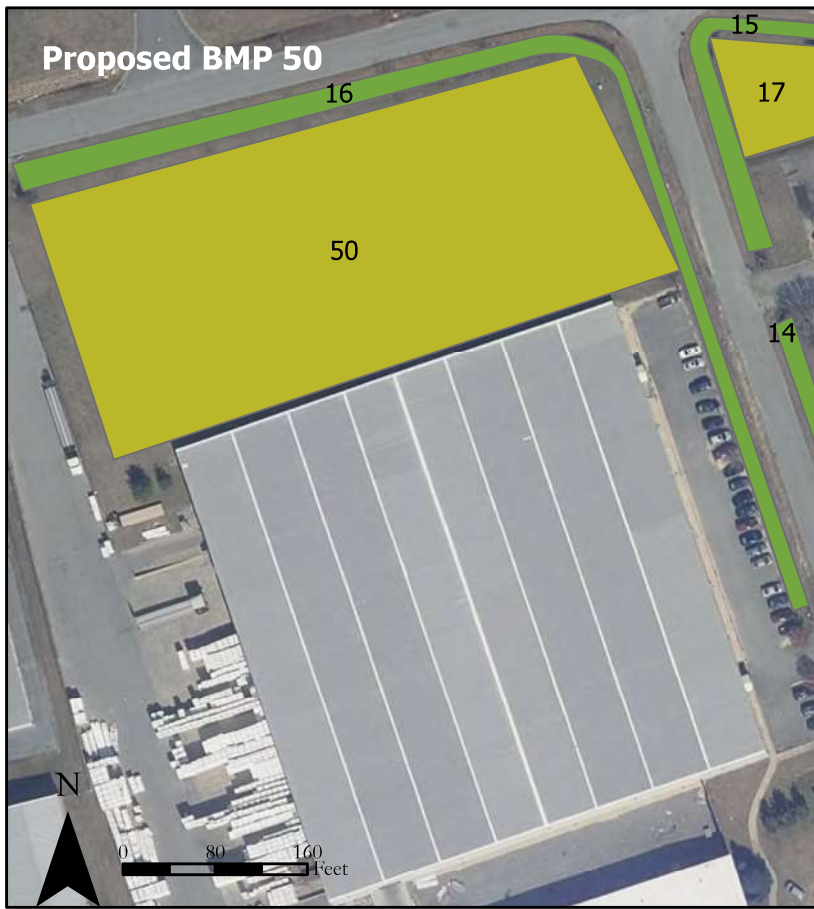
This site is located at on Engerman Ave in front of SEW Friel. The area is currently in grass and has the potential to be planted with native flowering plants and native trees to provide habitat and better infiltration.

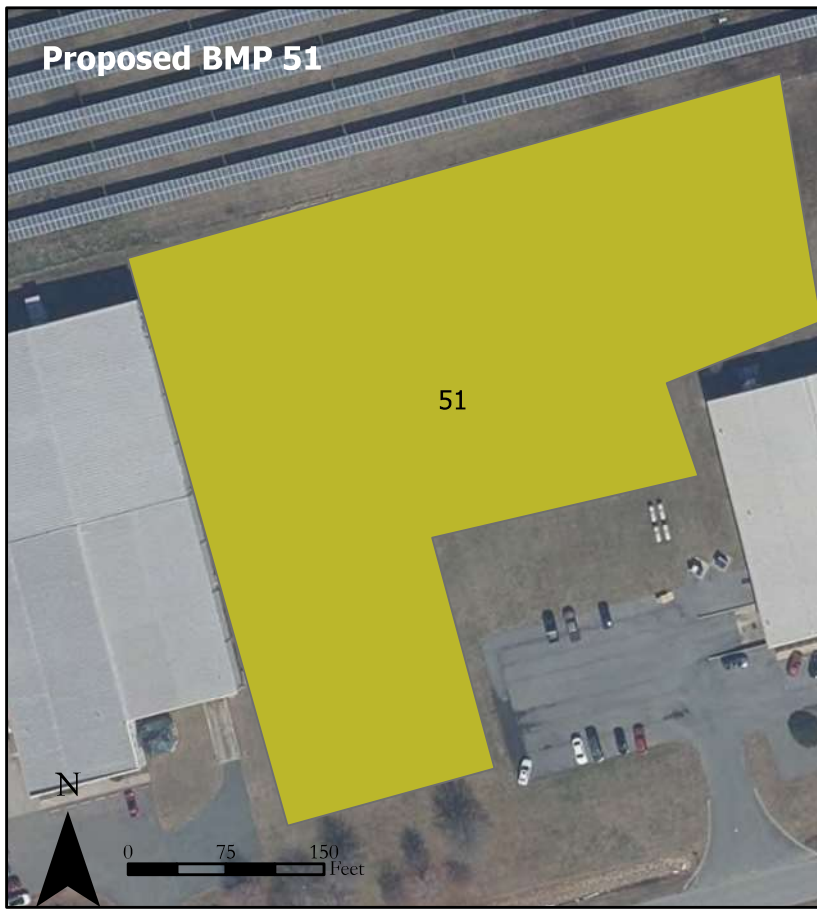
## Proposed BMP 51

This site is located on the Palmetto property just south of the Town of Denton property that has solar panels. At present the field is mowed grass. A native species meadow could be planted for pollinator habitat and provide better infiltration to attenuate some stormwater from the adjacent areas.

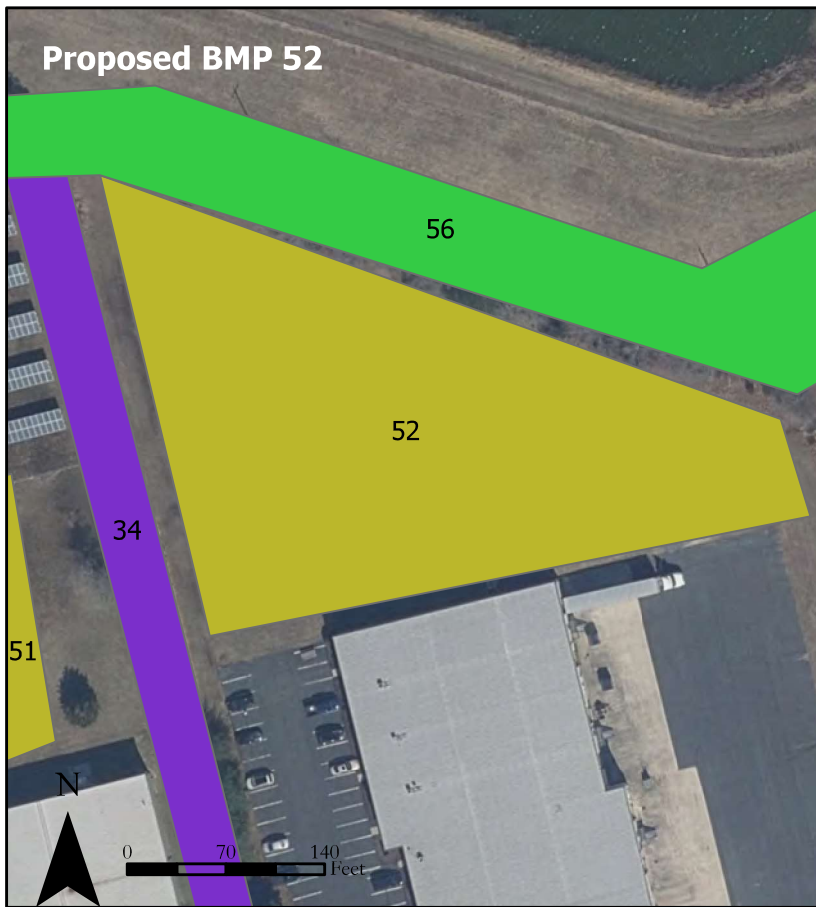
This site is located on the Lorry Industries property just south of the waste water treatment plant. At present the field is mowed grass. A native species meadow could be planted for pollinator habitat and provide better infiltration to attenuate some stormwater from the adjacent areas.

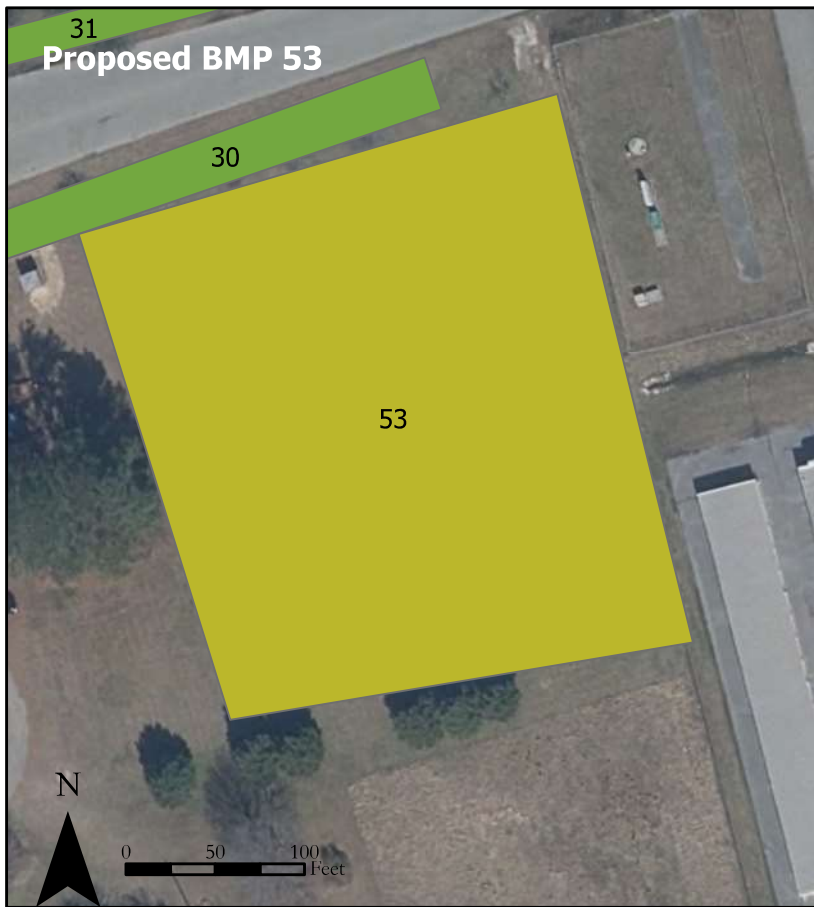
This site is located on the south side of Engerman Ave. near the U-Hual storage. At present the field is mowed grass. A native species meadow could be planted for pollinator habitat and provide better infiltration to attenuate some stormwater from the adjacent areas.
