# Poor House Run Hydrologic Assessment and Watershed Action Plan

April 1, 2022

## Appendix A: Project Sites and Estimated Nutrient and Sediment Reductions

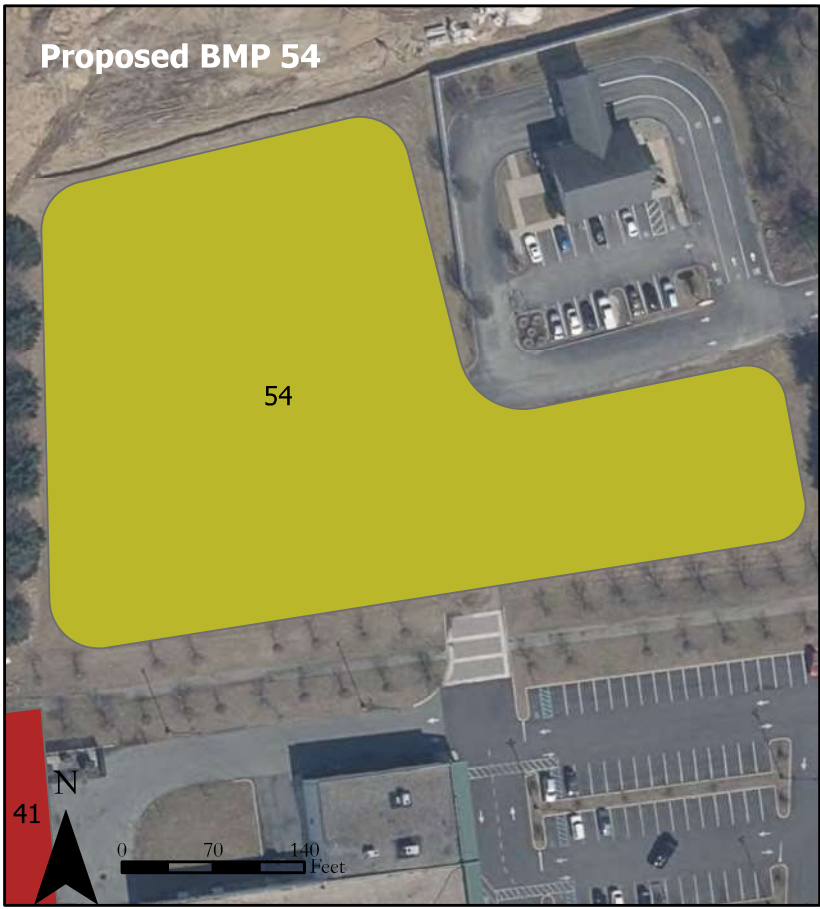
This site private property adjacent to PNC Bank. At present the field is mowed grass. A native species meadow could be planted for pollinator habitat and provide better infiltration to attenuate some stormwater from the adjacent areas.

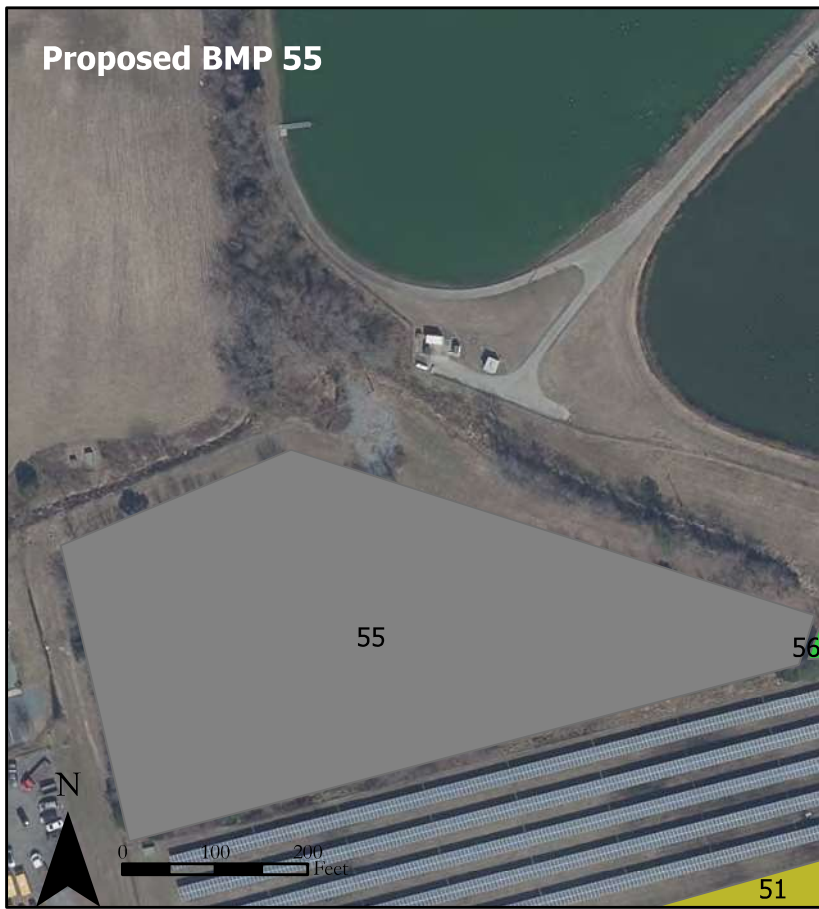
This site is la large stormwater pond owned by the Town of Denton. It is a major stormwater feature that collects water from a ditch south of the Waste Water Treatment Plant. It is in need of maintenance. It is a good candidate to be re-designed using newer stormwater standards to increase its efficacy at storing and treating stormwater.

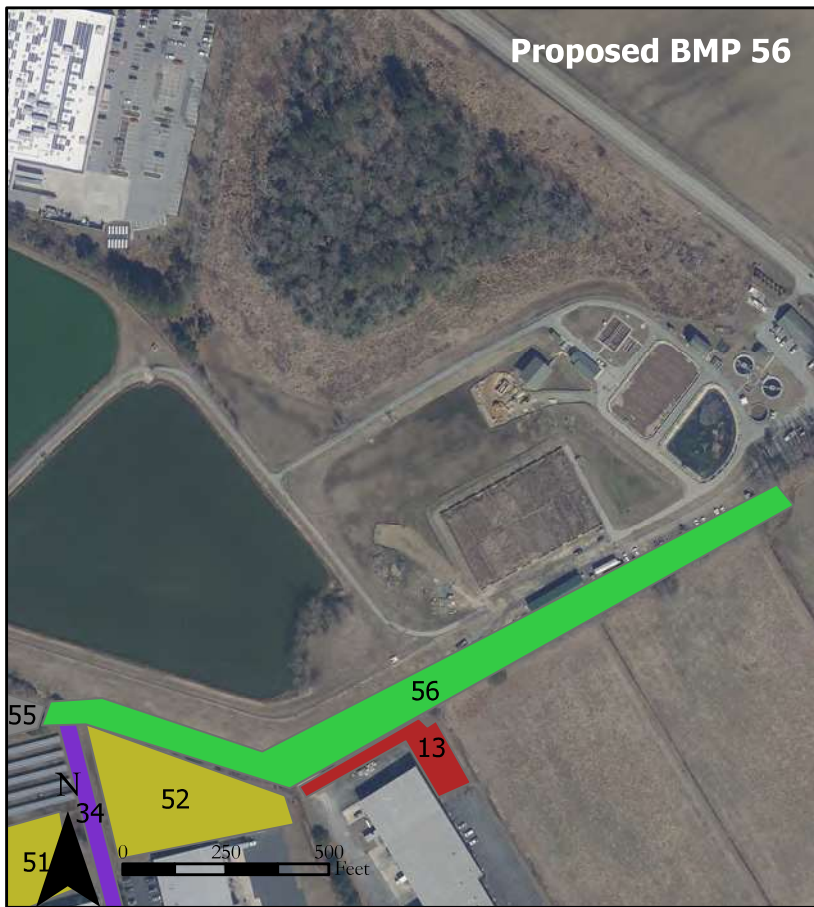
This site is located just south of the Waste Water Treatment Plant. The ditch presents an opportunity to better treat and store stormwater. The ditch could be expanded to hold more stormwater and created into a "swamp run" that would create habitat while still conveying stormwater.
