# Poor House Run Hydrologic Assessment and Watershed Action Plan

April 1, 2022

## Appendix A: Project Sites and Estimated Nutrient and Sediment Reductions

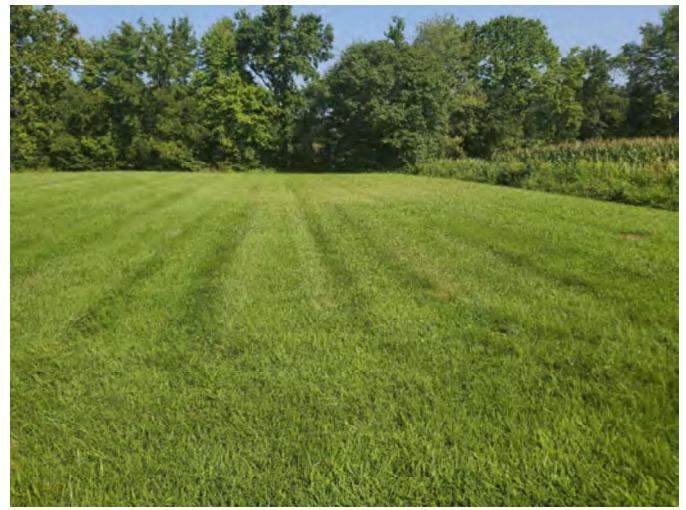
This bioretention site is located along Engerman Ave. at the back of Donovan Marine. This does not include the stream restoration which is a separate project. The area is just a mowed field that abuts the parking lot and a ditch. The building does not have any stormwater facilities but many downspouts that discharge to impervious surfaces. This area provides a good opportunity to treat the runoff from the building and the parking lot by installing a bioretention. The adjacent ditch should also provide an adequate outlet for the bioretention. Other site limitations such as utilities must be investigated further.

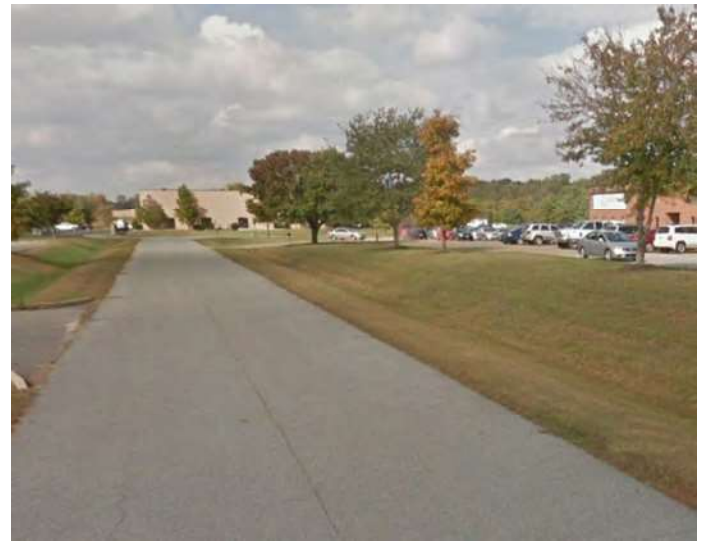
This grass swale is located between Park Ln. and an access road to UniSite design. There the grass swale is within a wide median strip that is mowed and has some landscaping trees. There is very little stormwater retention or attenuation benefit from the grass swale in its present condition. The swale could have native vegetation planted to reduce stormwater velocity and help provide some nutrient treatment as well as habitat value. There is room within the swale and median to create this swale into a bioswale with small check dams to encourage more infiltration to reduce stormwater volume.

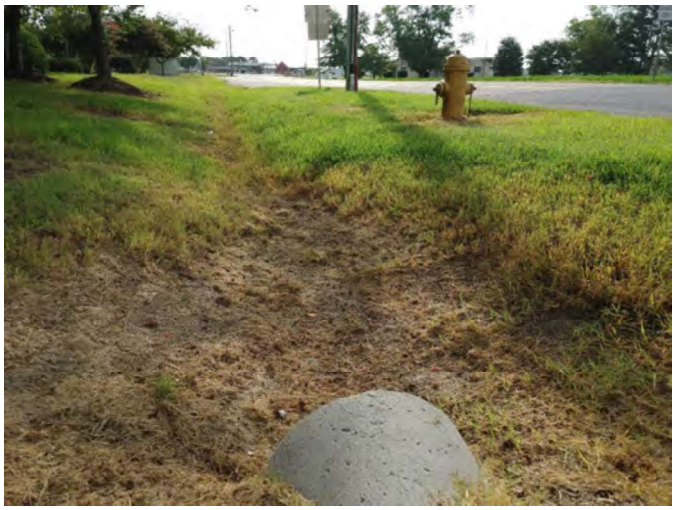
This grass swale is located off of Sharp Rd. near the back entrance to Rent-A-Center and Dollar General. The swale is maintained for conveyance and is mowed and herbicide is also applied to kill vegetation. This provides a very effective stormwater conveyance directly into the ditch. The back entrance was added sometime in 2014 and changed how water moved in this area. Previous to 2014 the grassed swale was larger. There is some room to expand the swale to attenuate some of the stormwater but this project would need to be completed in conjunction with BMP 19 to ensure that the best stormwater outcome can be achieved.

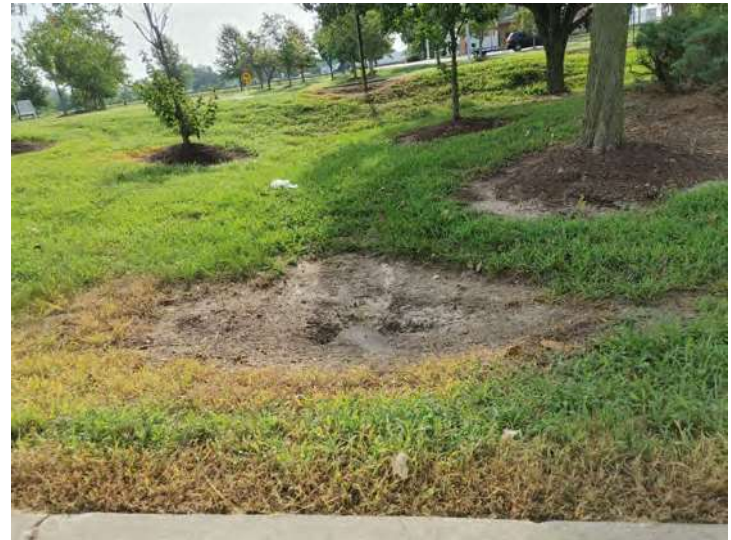
This site is located on the north side of the Dollar General Parking lot. The existing swale is vegetated with grass and mowed. There are no stormwater features to reduce volume and the grass that is existing does little to address stormwater velocity. The swale could be planted with native vegetation to help increase nutrient uptake and provide some reduction of peak stormwater velocities. The swale could also be upgraded into a bioswale if there is enough room to work in to amend the soils and add small check dams to temporarily pond water.

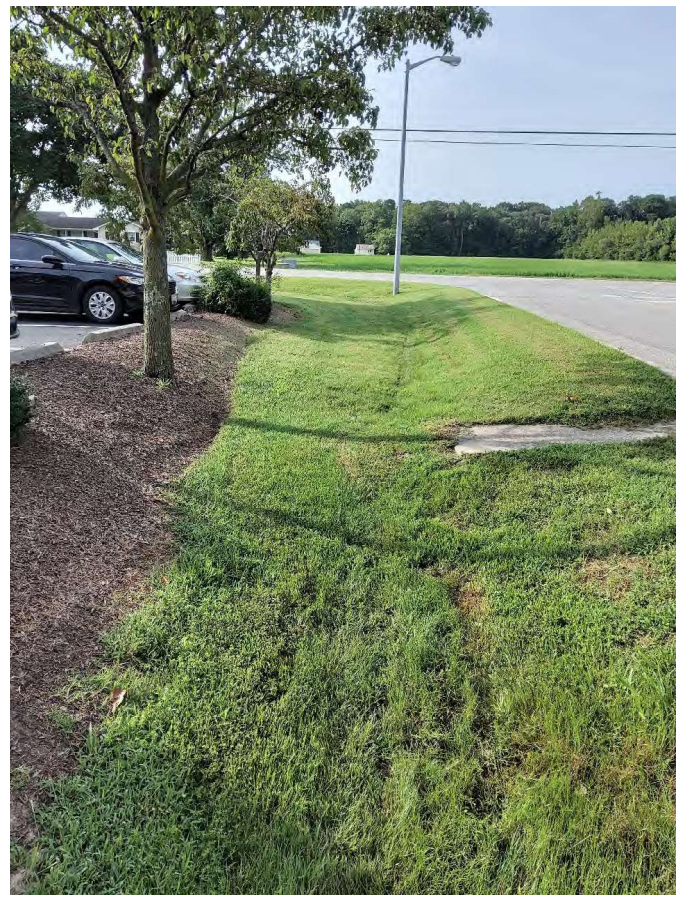
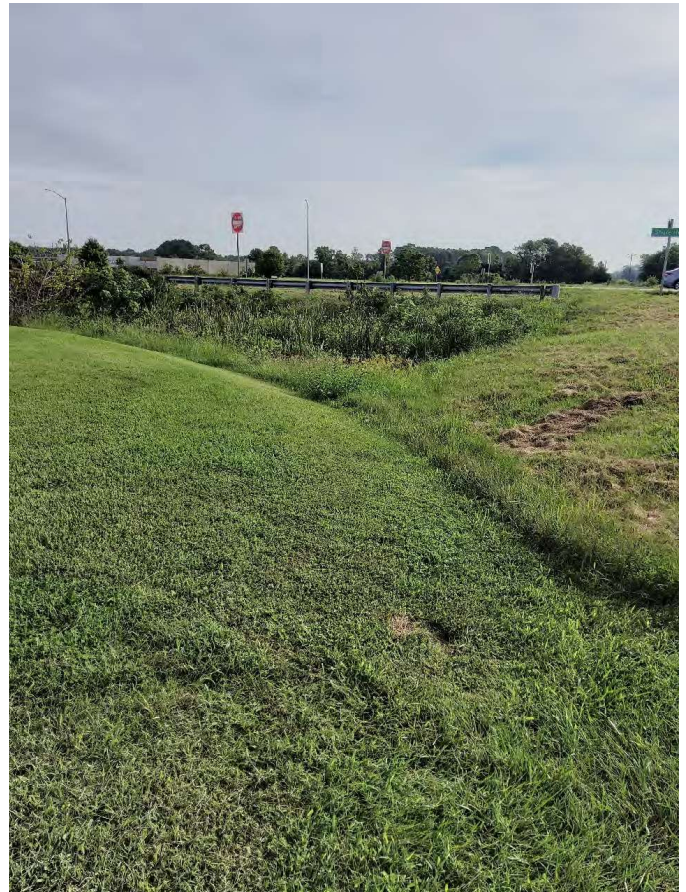
This site is located on the south side of Shore United Bank adjacent to Sharp Rd. The existing swale is vegetated with grass and mowed and there are some landscaping trees. The swale drains to a roadside ditch along 404. There are no stormwater features to reduce volume and the grass that is existing does little to address stormwater velocity. The swale could be planted with native vegetation to help increase nutrient uptake and provide some reduction of peak stormwater velocities. The swale could also be upgraded into a bioretention/bioswale if there is enough room to work in to amend the soils and if there are no conflicts with utility right of way.

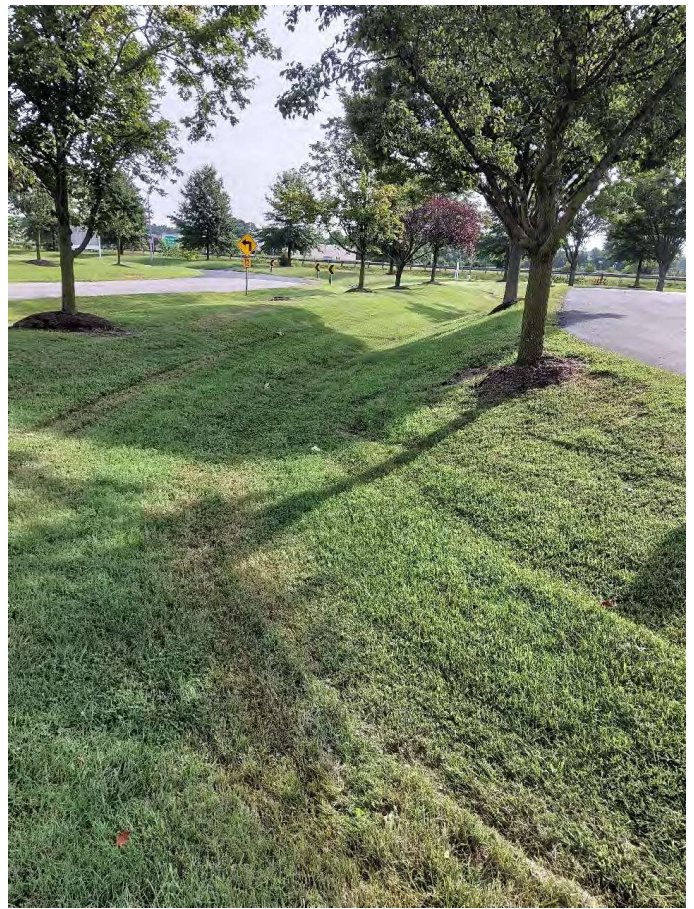
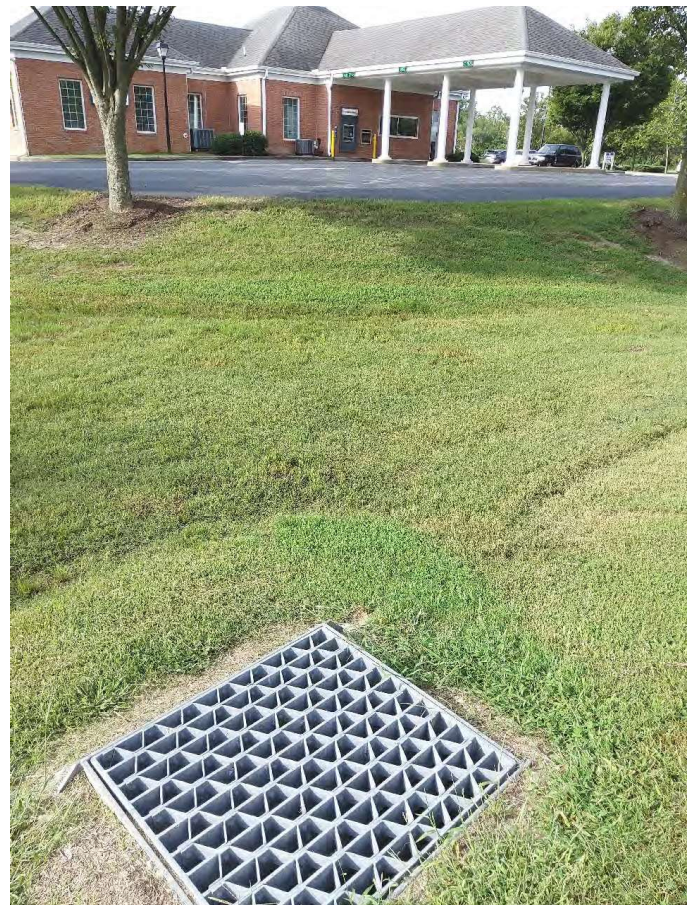
This site is located on the north side of Shore United Bank adjacent to 5th St. The swale is mowed grass and has a few landscaping trees. There are no stormwater features to reduce volume and the grass that is existing does little to address stormwater velocity. The swale could be designed to be a bioretention area that is able to store and infiltrate stormwater. Further down the swale another bioretention or small stormwater facility could be added were there is an existing storm drain inlet (BMP 39).

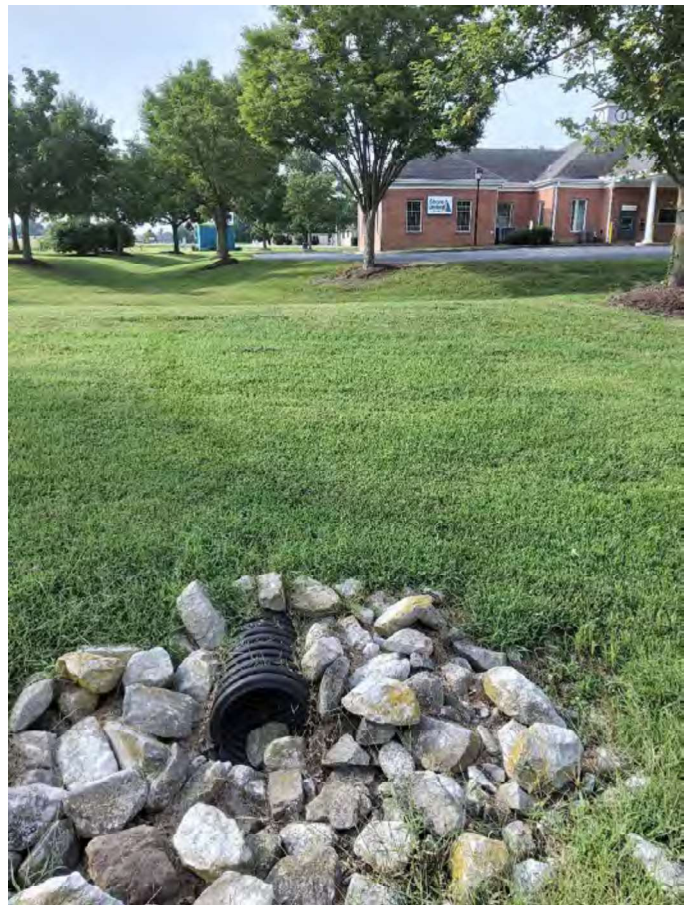
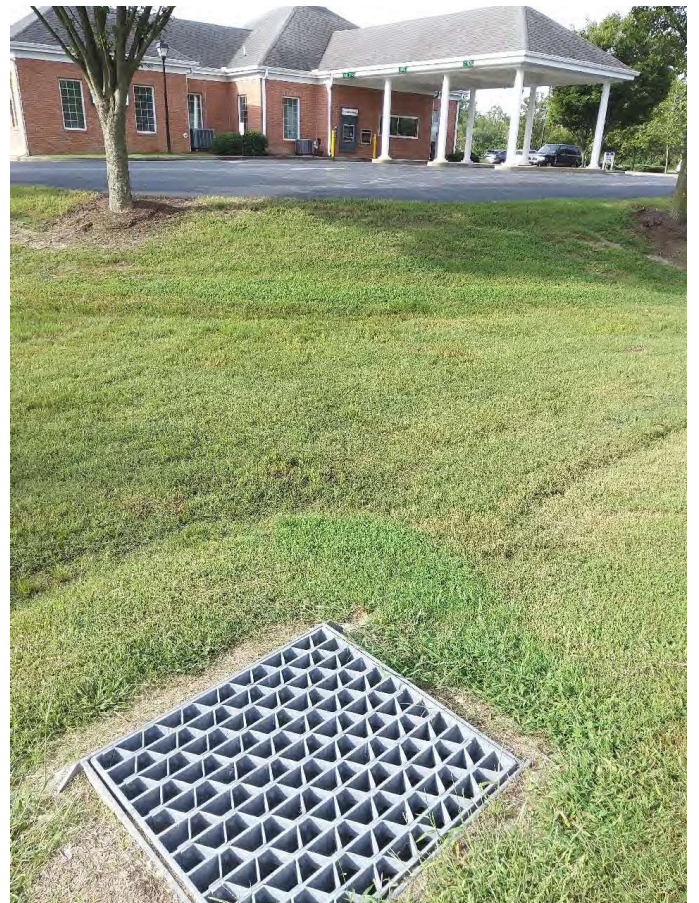
This site is located on the east side of Shore United Bank. The swale is mowed grass and has a few landscaping trees. There are no stormwater features to reduce volume and the grass that is existing does little to address stormwater velocity. The swale could be designed to be a bioretention area that is able to store and infiltrate stormwater.

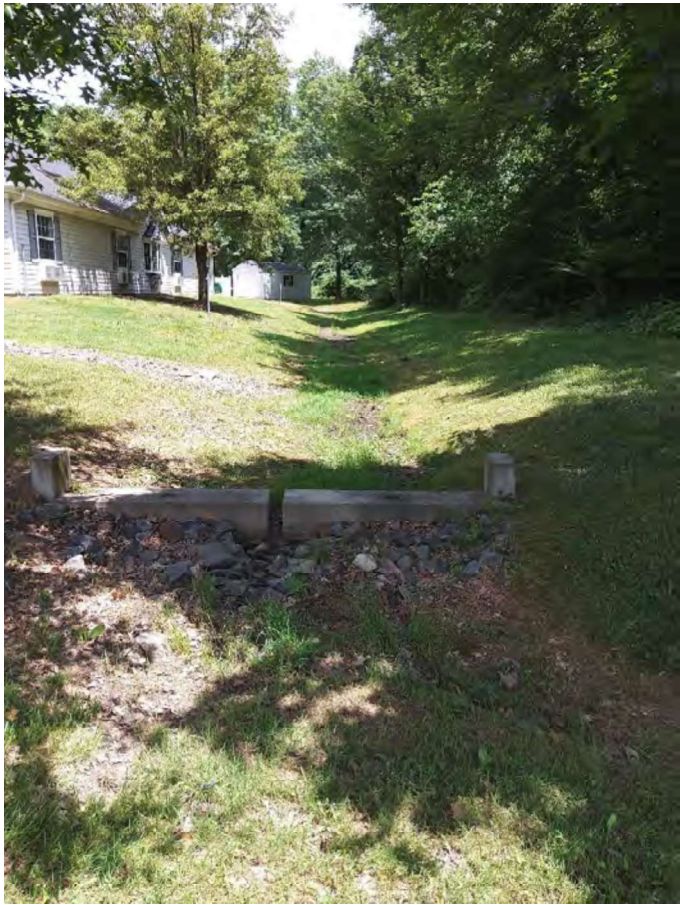
This site is located at the back of Food Lion and in Sharp Road Community Park . The impevious area drains into a stormwater pond at the south end of the proposed bioretention. Working with the town and the private landowner a bioretention could be designed to help store and treat stormwater before it goes into the stormwater pond.

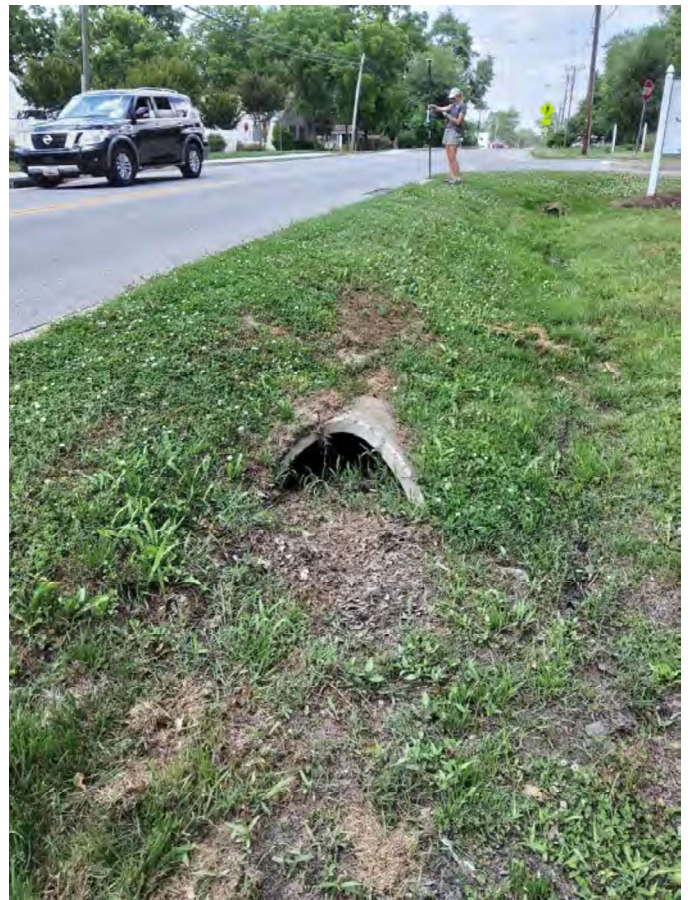
This site is located along 5th St. The swale is grassed and mowed. The swale drains directly to the north culvert that carries the norther tributary of Poor House Run and goes under 5th St. There might be some room between the road and the forest to put in a linear stormwater feature to reduce peak stormwater flow going down into the culvert. There might be opportunity to divert this flow into the forest to better treat and store stormwater. This BMP might be able to tie into BMP 49.

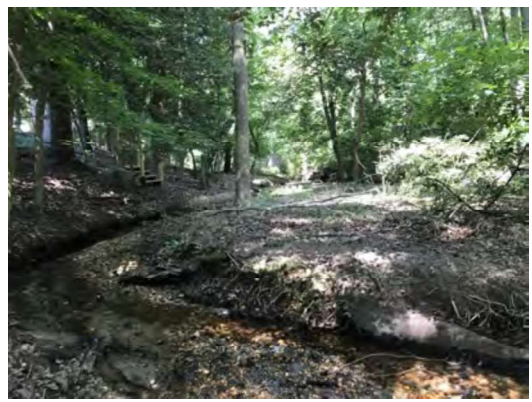
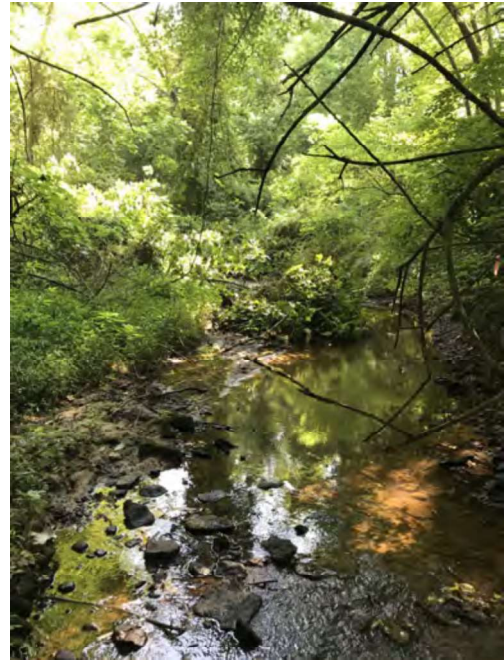
This site is along the Poor House Run stream corridor. This part of the stream is relatively stable but disconnected from the floodplain. Natural channel design that uses soft engineering (wood and small structures) could be used to help reconnect the floodplain to help with flood attenuation. The stream restoration design needs to be designed to account for future changes in the watershed that could increase peak stream discharge during storm events.

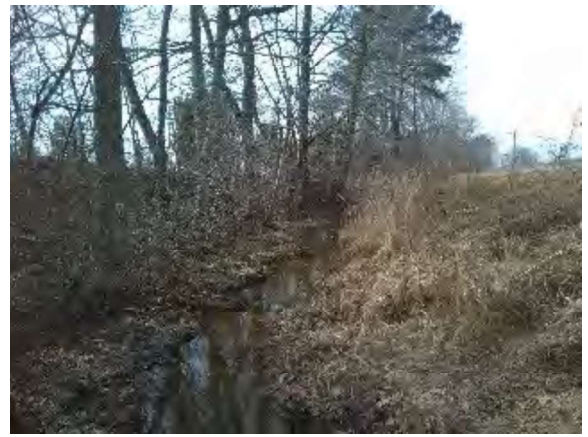
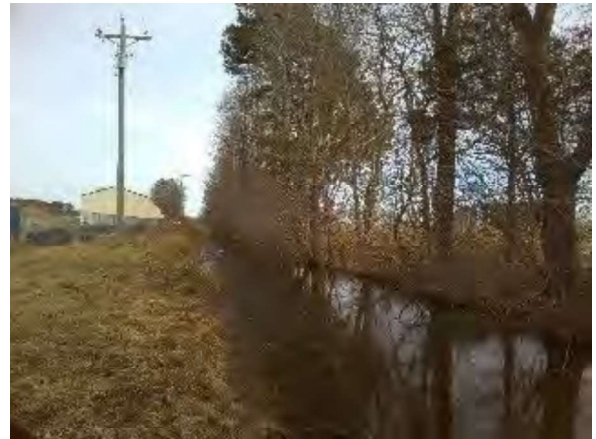
This site is located just south of the Waste Water Treatment Plant. The ditch presents an opportunity to better treat and store stormwater. The ditch could be expanded to hold more stormwater and created into a "swamp run" that would create habitat while still conveying stormwater.
